**MUNICIPAL BUILDINGS FACILITY CONDITION ASSESSMENT  
CITY OF BERKLEY, MICHIGAN**

**AUGUST 2014**

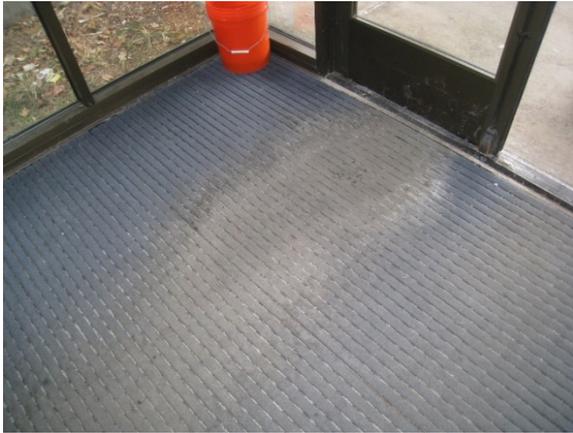
Deteriorating walk-off mat at main entry.

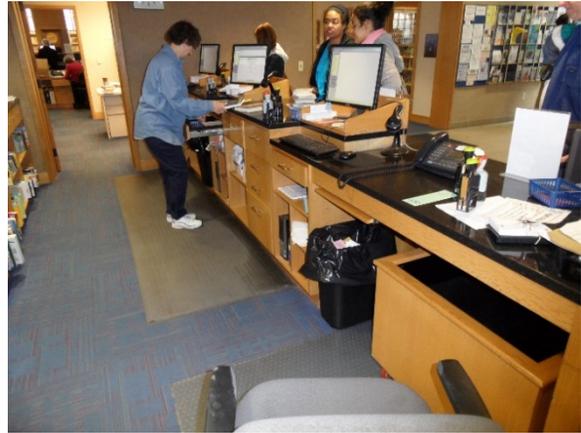
Circulation desk is not ADA compliant.

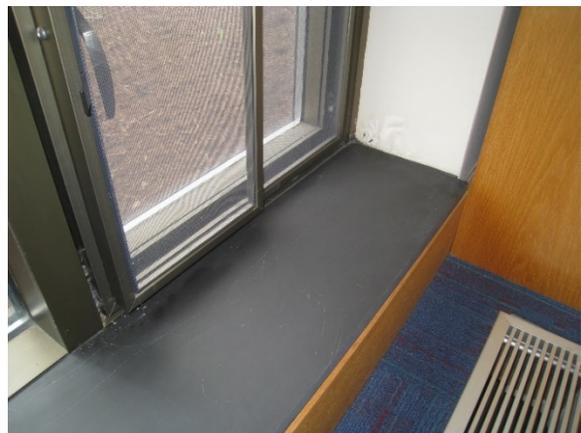
Some windows allowing water infiltration. Raised grade may be a contributing factor.

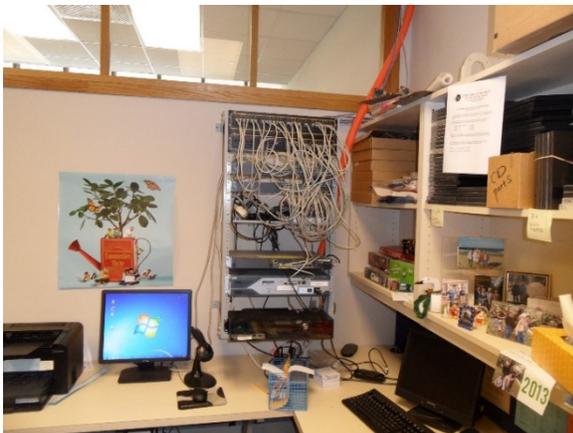
Data cabling is exposed and cable management is recommended.

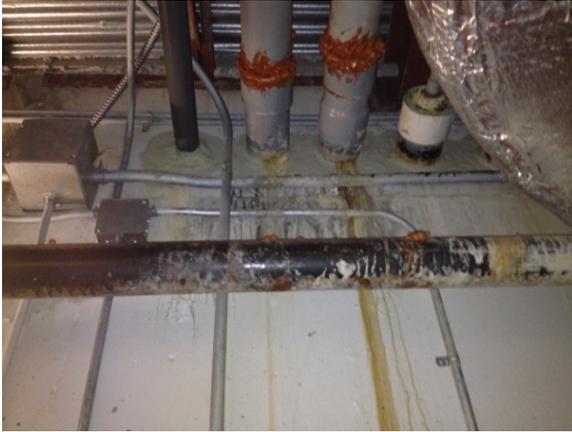
Water infiltration and damage at the main electrical conduits into the basement.

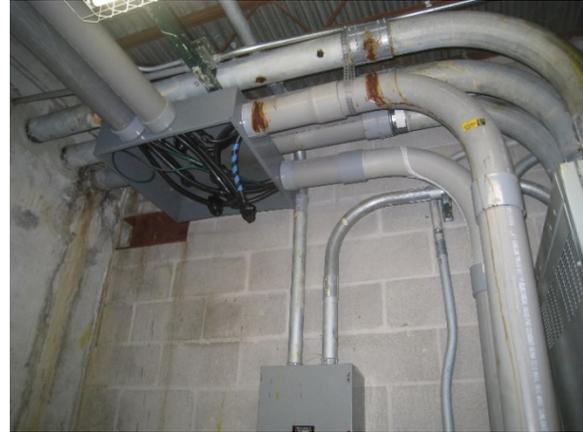
Damaged junction box on main electrical feed between Public Safety and City Hall. Water infiltration indicated as continuing.

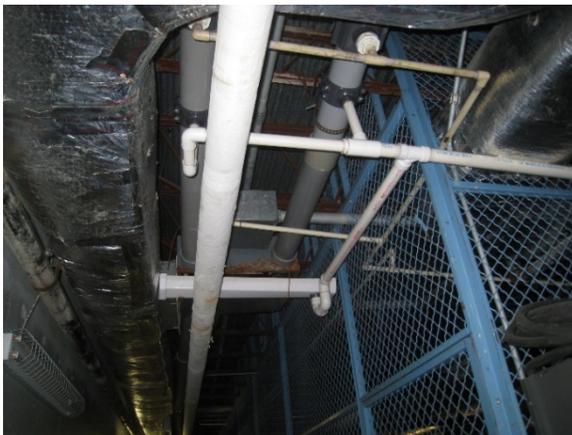
Piping and gutter system added to redirect water flow from conduit.

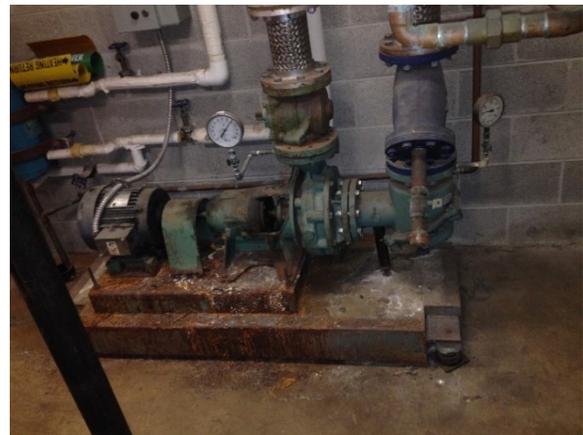
Vibration isolation base on water pump severely deteriorated due to water exposure.

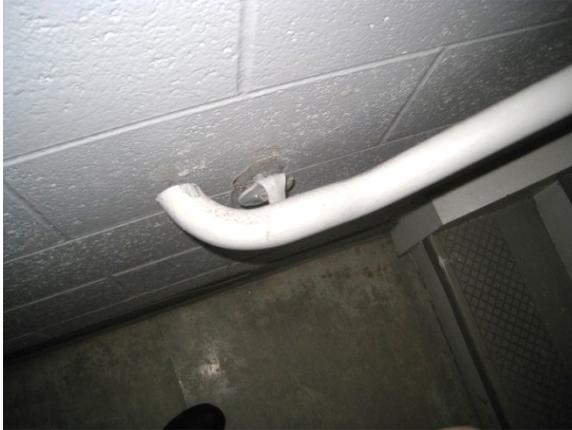
Stair handrails have separated from the wall and should be reattached.

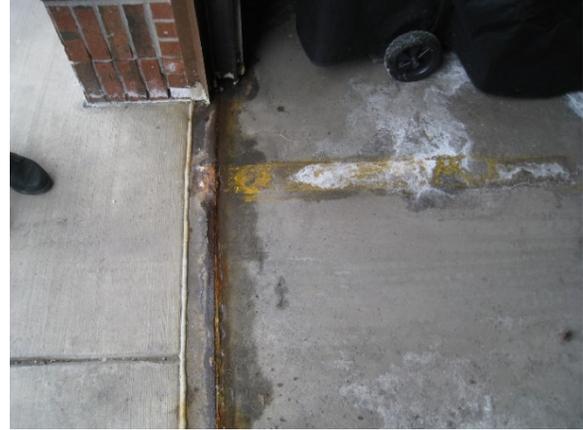
The joint between the police car garage slab and the exterior slab is a point of entry for rain water, causing damage to the basement walls, structure and stored items in the evidence room below. This joint should be repaired.

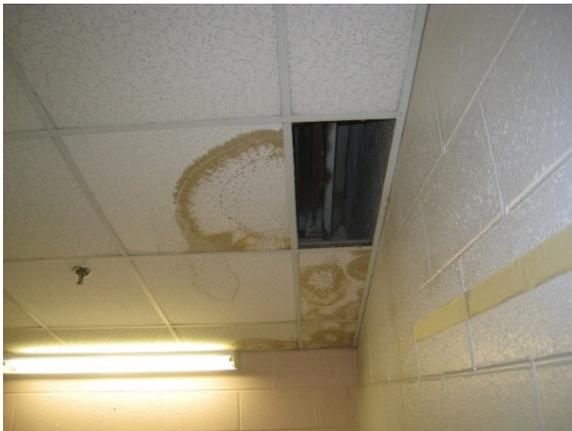
Ceiling tile damage is indicative of roof leaks. The standing seam metal roof appears to be leaking at roof height transitions.

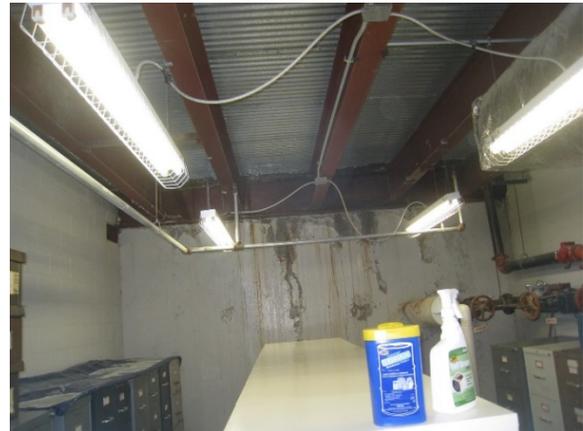
Water damage in the basement evidence storage room. This is directly below the police car garage door shown above.

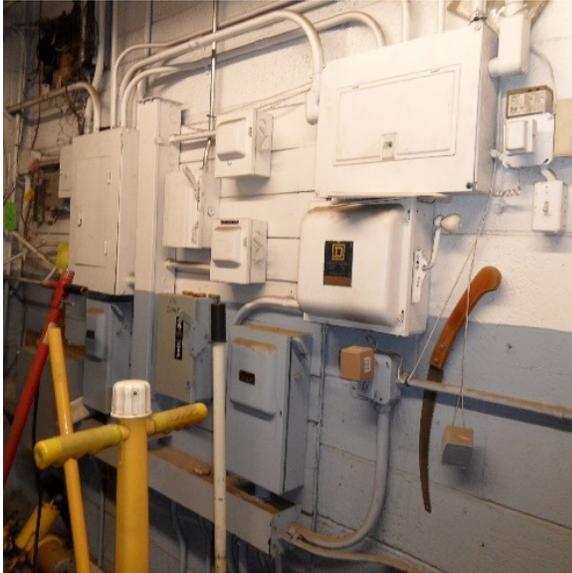
The electrical system is difficult to access, heavily modified, complex and obsolete.

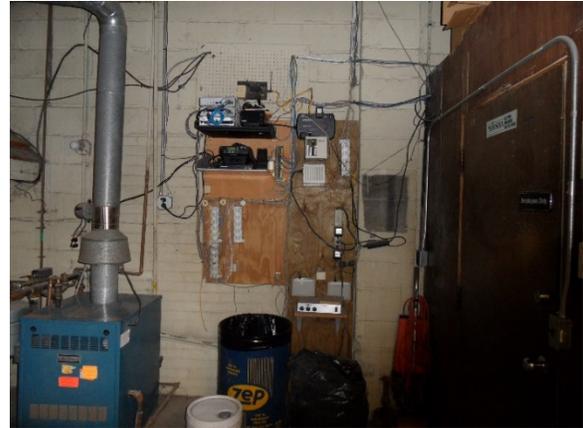
Data equipment is located near the boiler, and should be relocated.

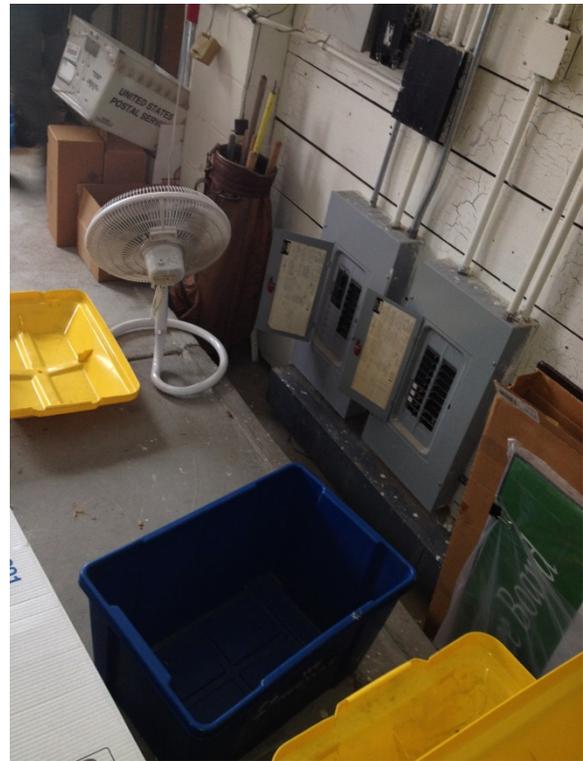
Electrical equipment is antiquated and located in places where access is limited and damage is likely (too near the floor).

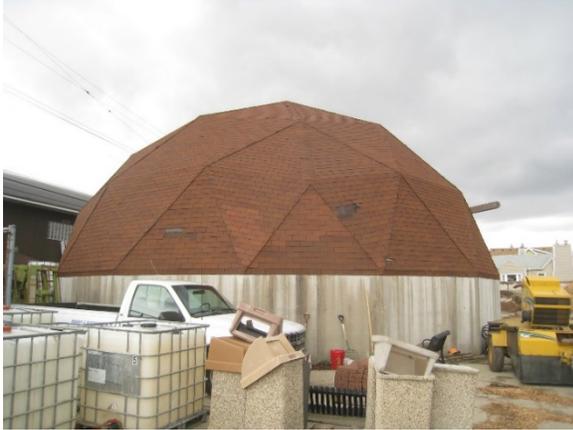
Shingles on roof are original and failing.

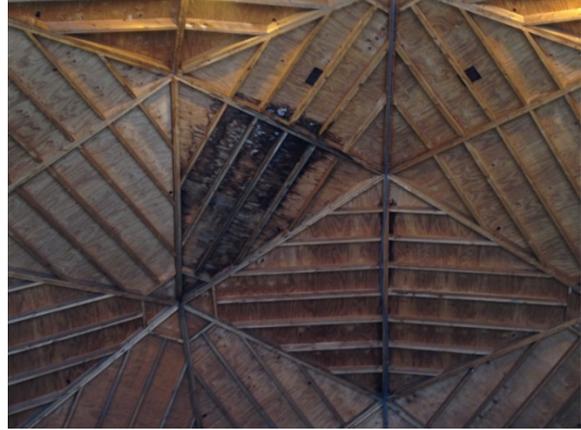
Water damage to the underside of the roof structure.

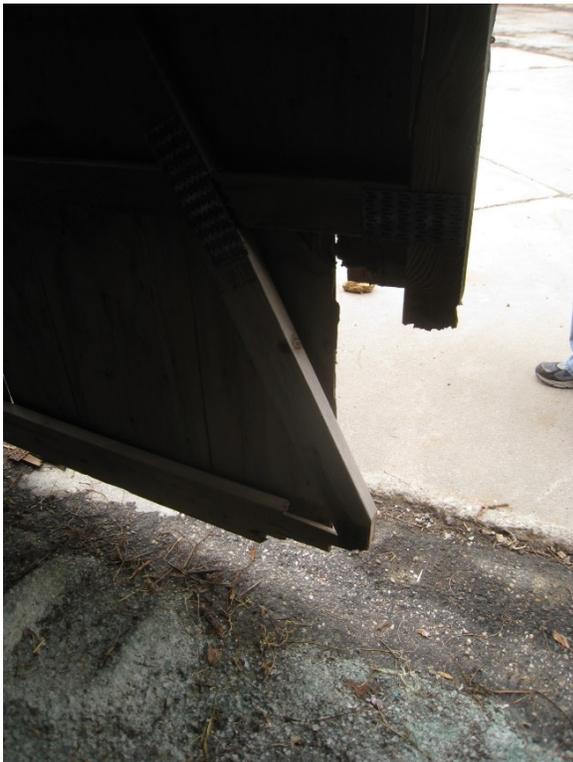
Damage at salt dome door.

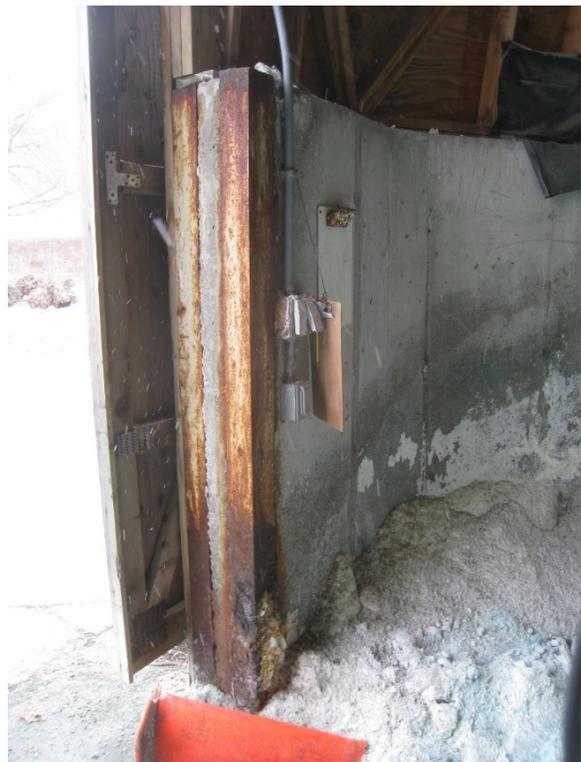
Typical deterioration of steel angle at entry.

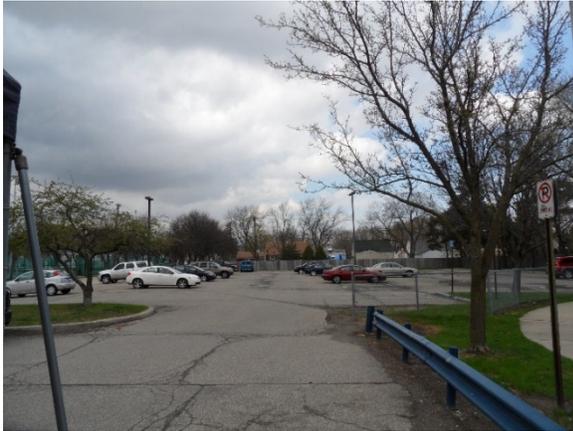
North parking lot and adjacent stockade fence deteriorated.

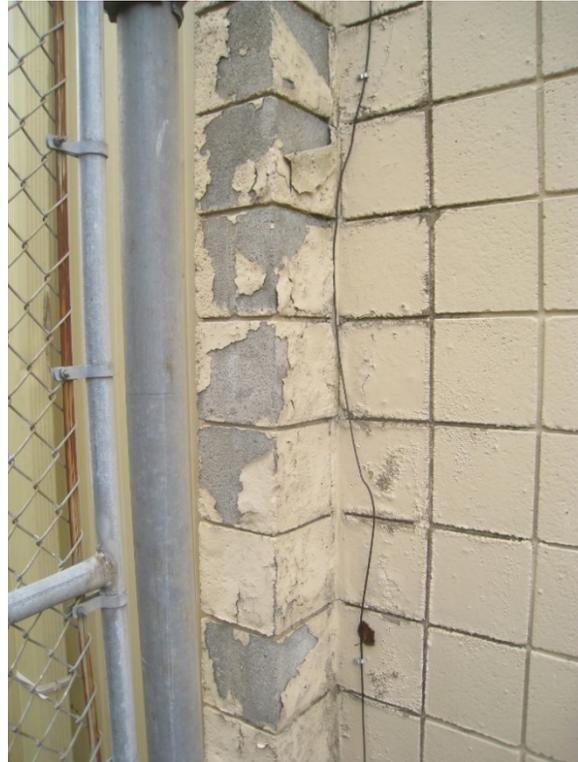
Block wall showing signs of water damage from roof runoff.

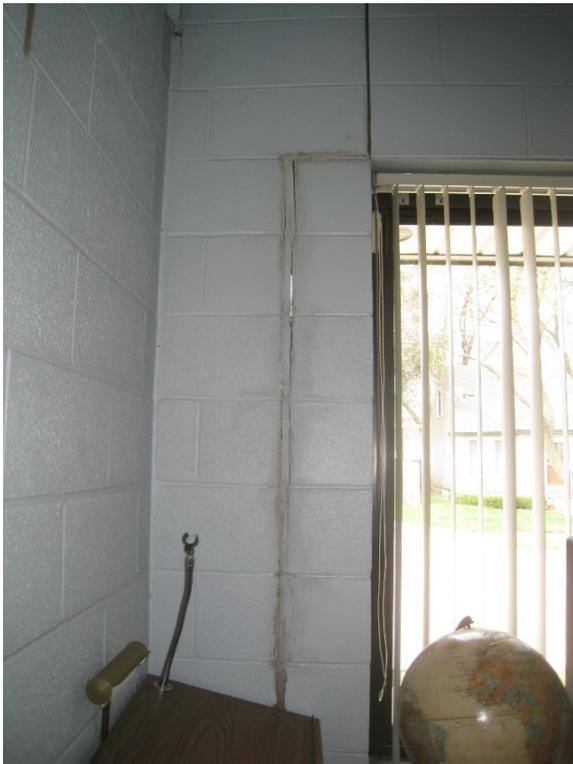
Settlement causing exterior block wall to rotate and separate.

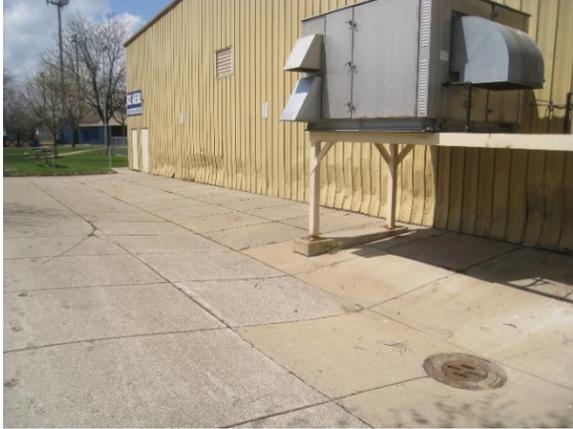
Exterior cladding damaged from ice and equipment.

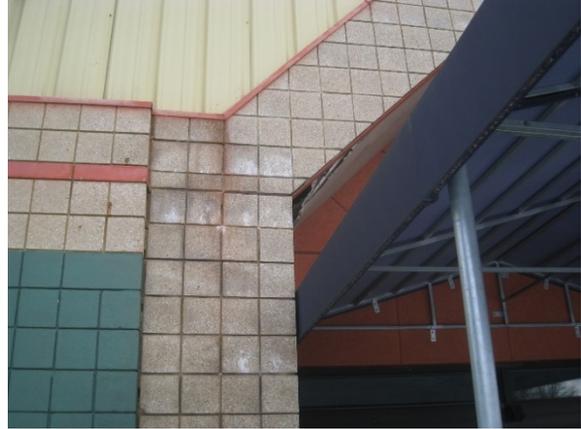
Block and soffit showing signs of water infiltration.

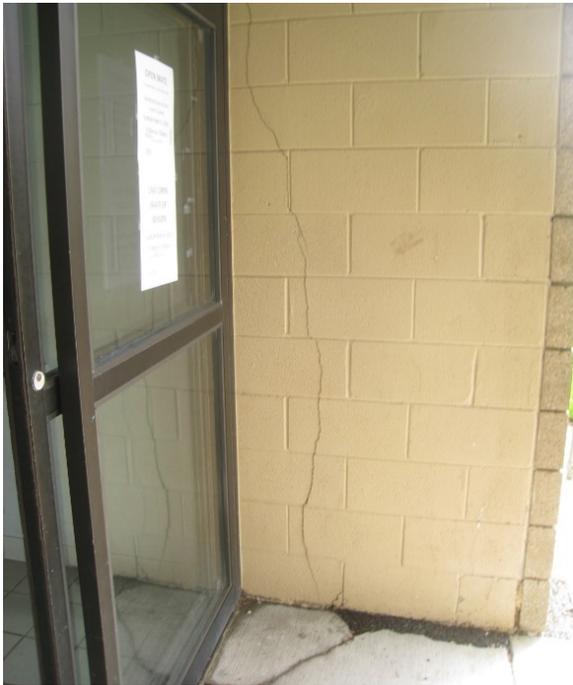
Block wall showing signs of structural movement.

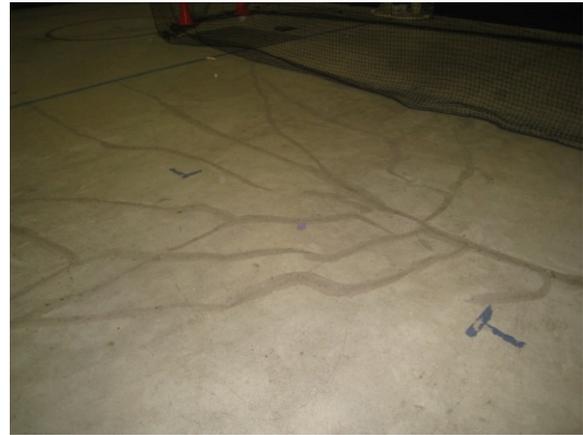
Studio rink floor cracked, disabling chiller system.

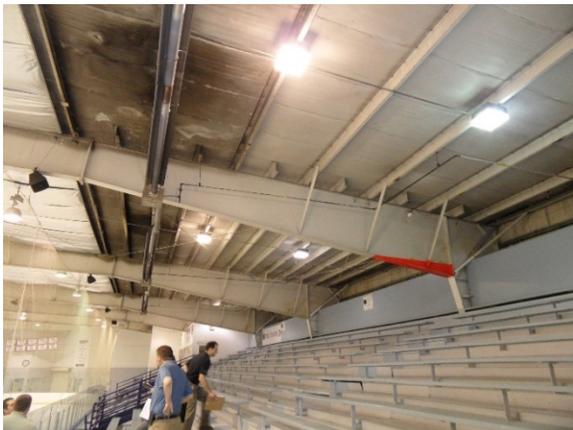
Steel structure obstructs walking path in upper bleachers.

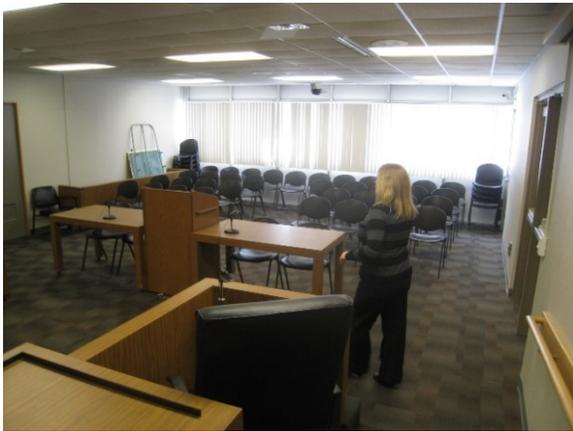
Council chamber/courtroom highly visible from parking lot.

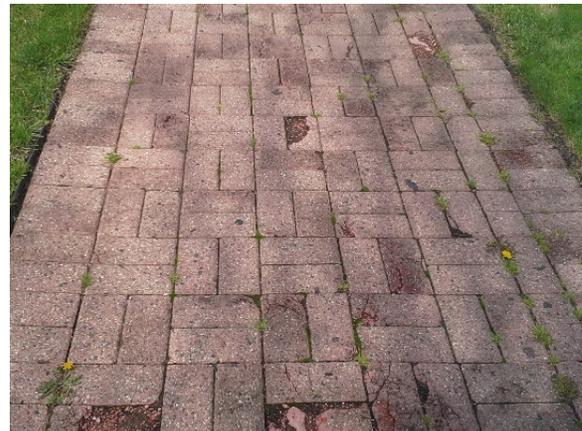
Brick pavers at north side of building deteriorated.

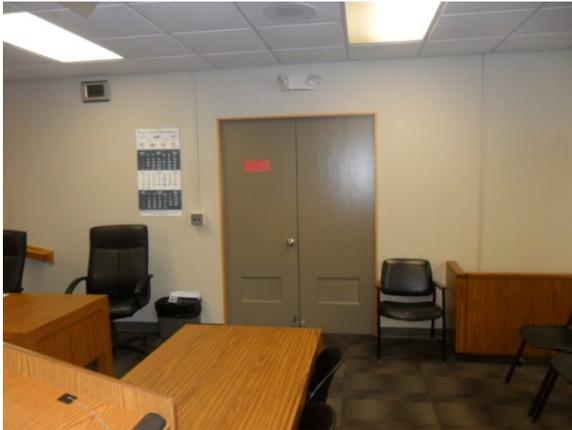
Council Chamber doors swing inward, not out, door is narrow, knob hardware is inappropriate

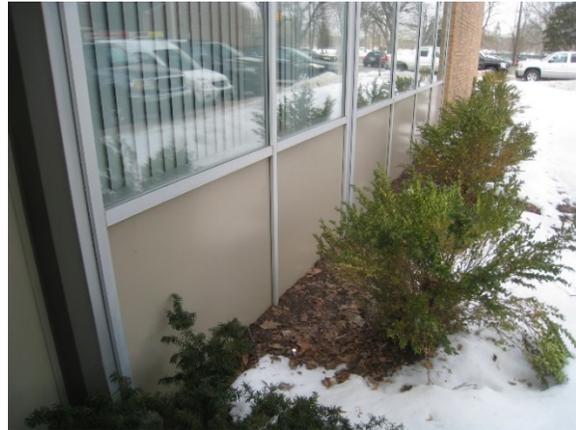
Grade is pitched toward building, allowing water infiltration.

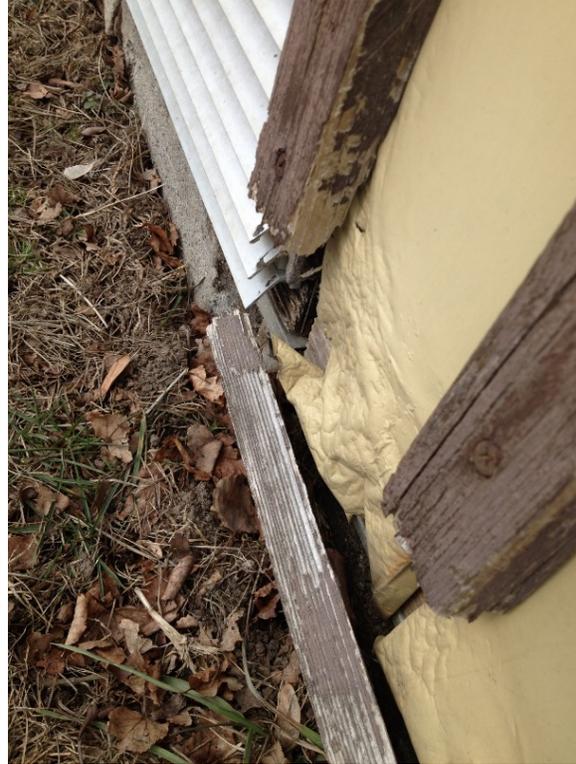
Close up of typical conditions at the base of the exterior wall.

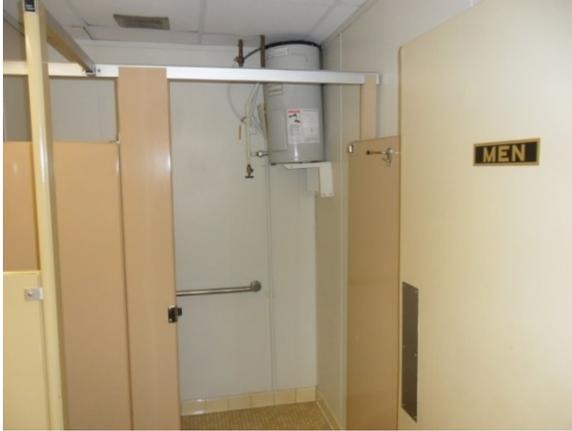
The water heater is exposed in the restroom, a potential injury hazard.

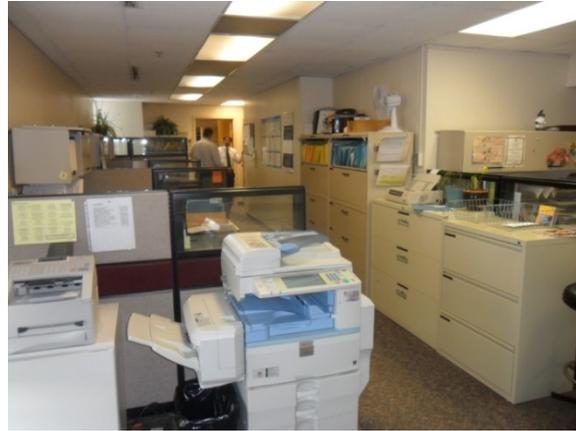
The court office space is insufficient.

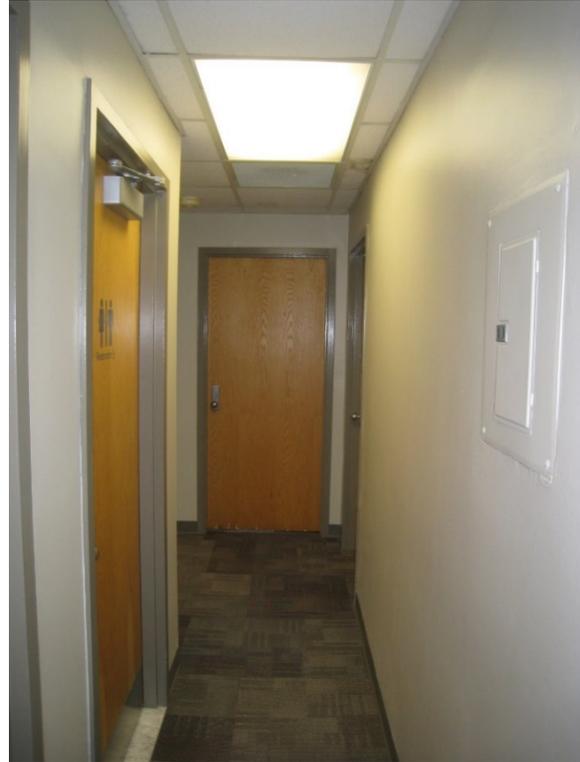
The corridors are not wide enough for ADA access/

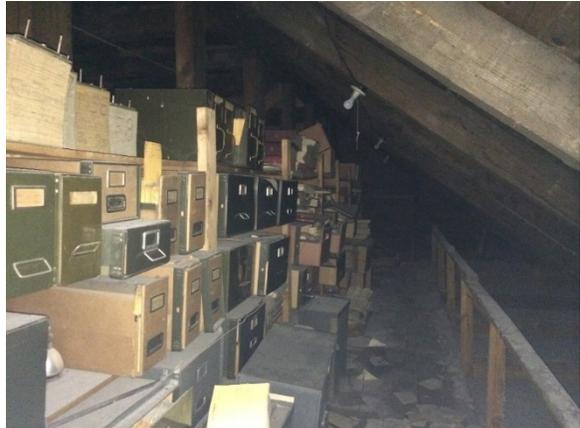
The attic contains excessive storage.

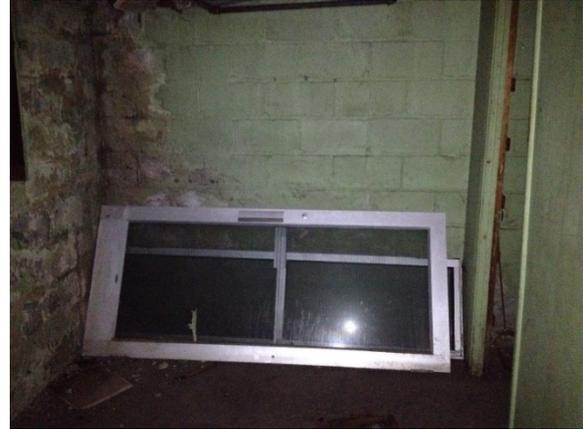
Basement walls show signs of excessive water infiltration.

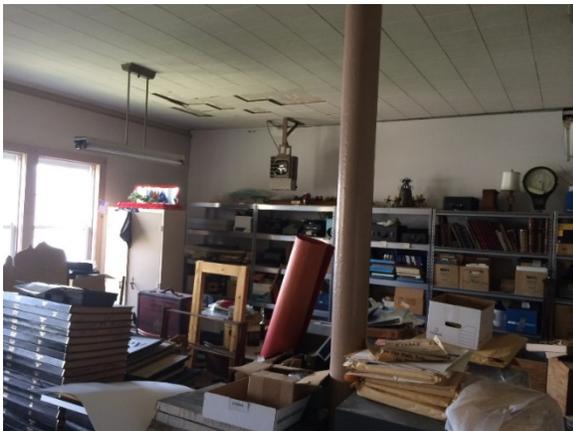
The entire second level is used for storage. There is insufficient climate control and no fire suppression system.
