**MUNICIPAL BUILDINGS FACILITY CONDITION ASSESSMENT  
CITY OF BERKLEY, MICHIGAN**

**AUGUST 2014**

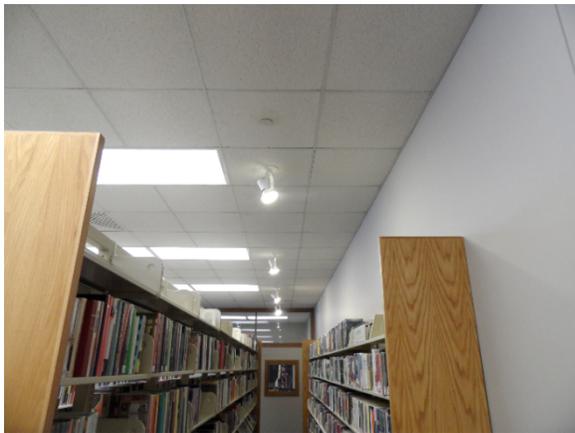
Stack areas appear to be over-lit, a potential waste of electricity.

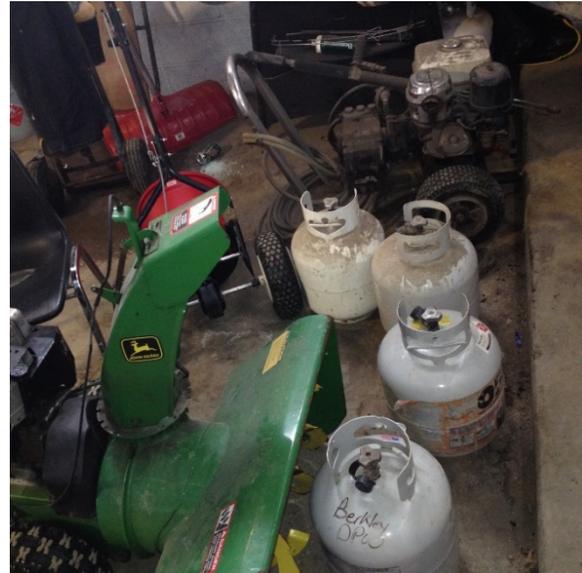
Flammable items are stored inside the building.

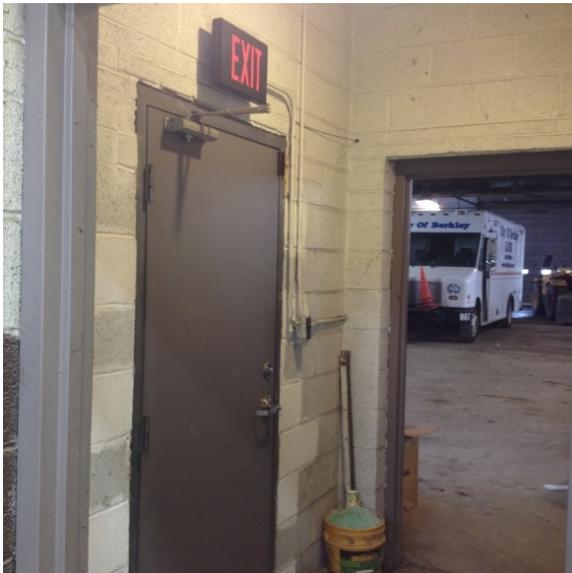
Several doors in the building are labeled as exit doors, but swing inward and have non-egress door hardware. This issue should be resolved by installing new doors or reconfiguring the path of egress to not require these doors as part of the path.

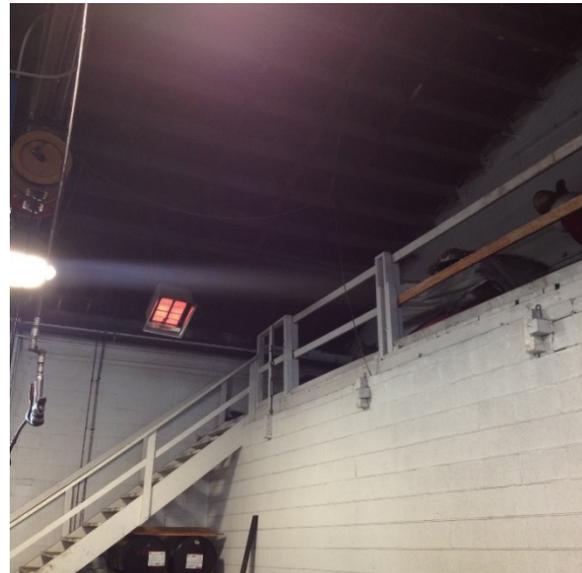
The storage mezzanine railings and stair rail are very low and open.

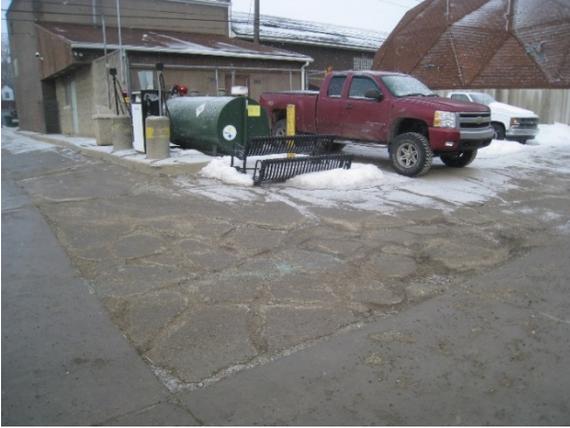
Much of the parking lot is showing signs of wear and deterioration.

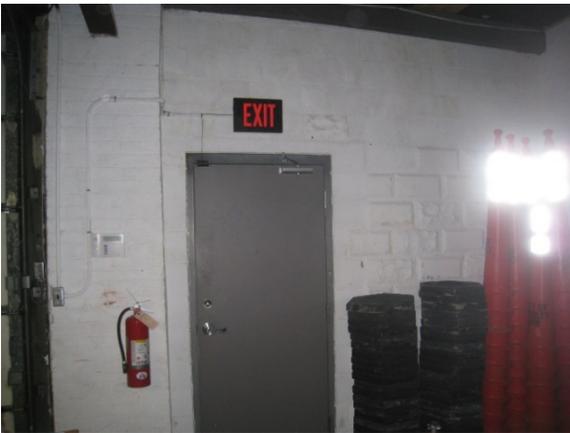
Several doors in the building are labeled as exit doors, but swing inward and have non-egress door hardware. This issue should be resolved by installing new doors or reconfiguring the path of egress to not require these doors as part of the path.

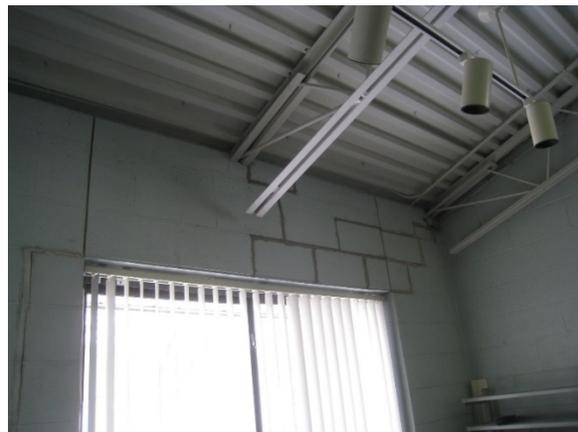
Settlement causing exterior block wall to rotate and separate.

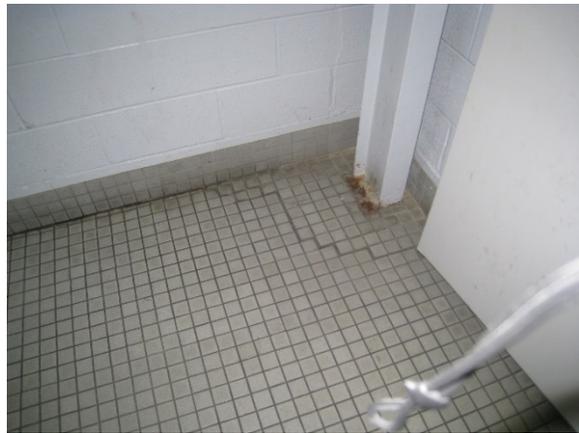
Bathroom floor showing signs of settlement.

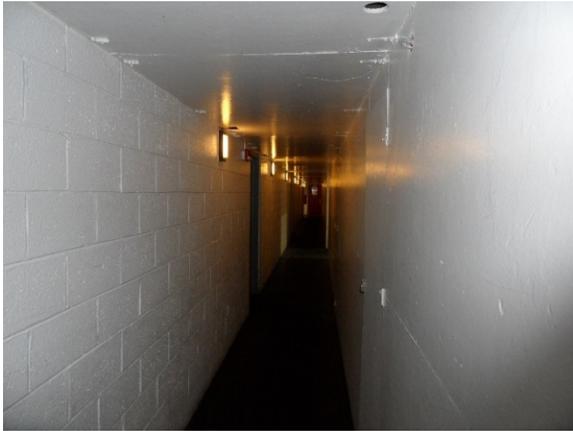
Corridor under bleachers poorly lit and narrow.

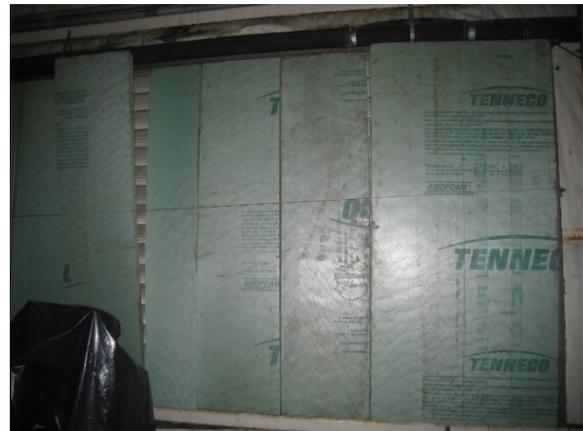
Mechanical equipment room louvers not properly sealed.

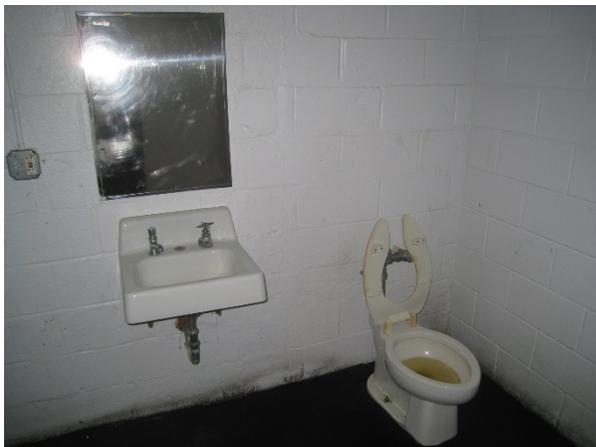
Outdated plumbing fixtures in toilet room.

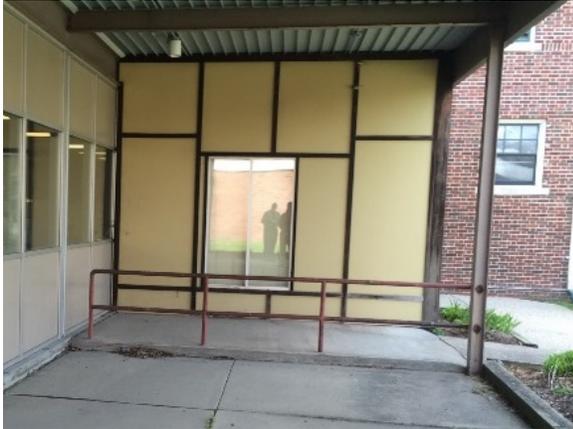
Deteriorating plywood sheathing at west entry.

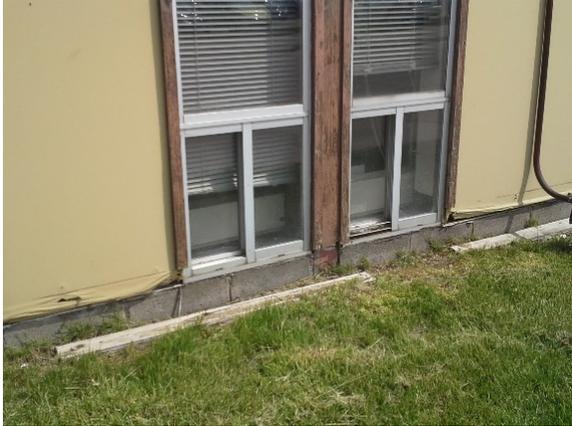
Windows, exterior cladding and trim have failed. The building is not able to keep out the elements or vermin.

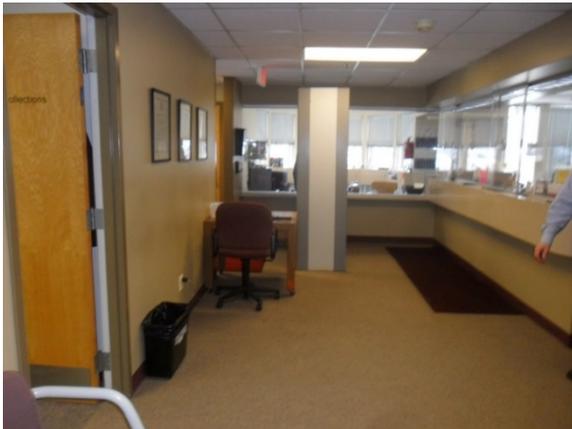
The limited size and layout of the lobby makes security a challenge, especially when victims and the accused move through the space at the same time.

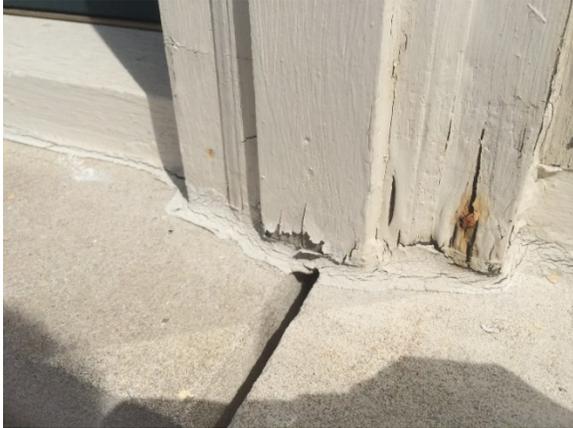
Exterior wood trim is due for repair and repaint.

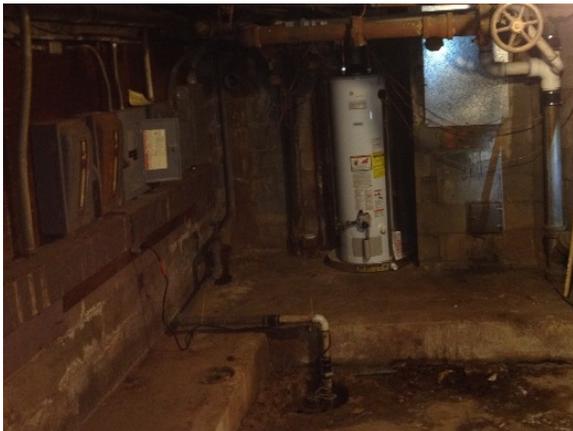
Electrical equipment in basement is outdated and has insufficient clearances.

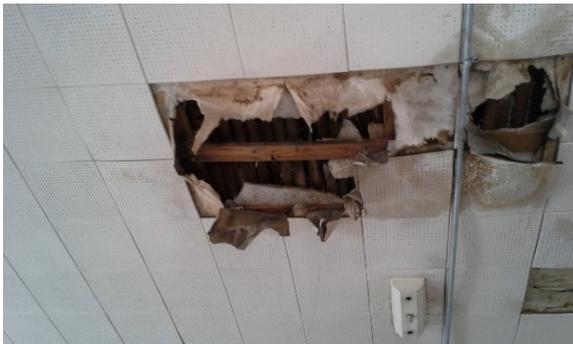
The ceiling on the second level has failed.

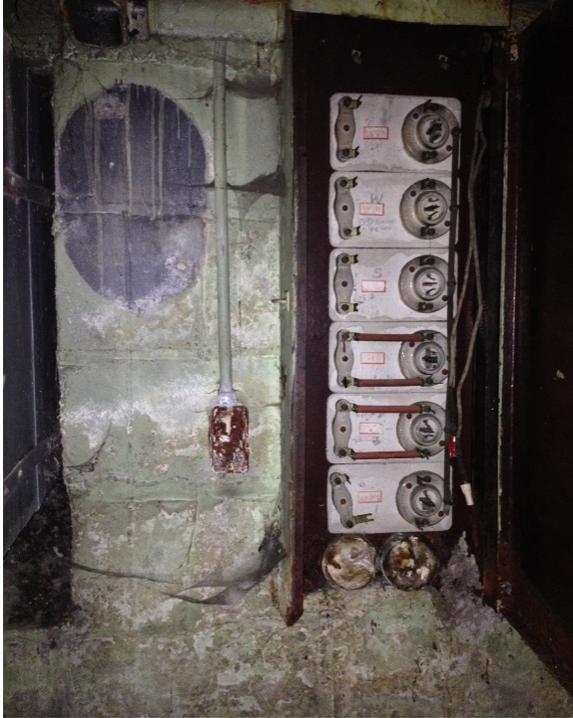
Electrical equipment in basement is outdated and abandoned.

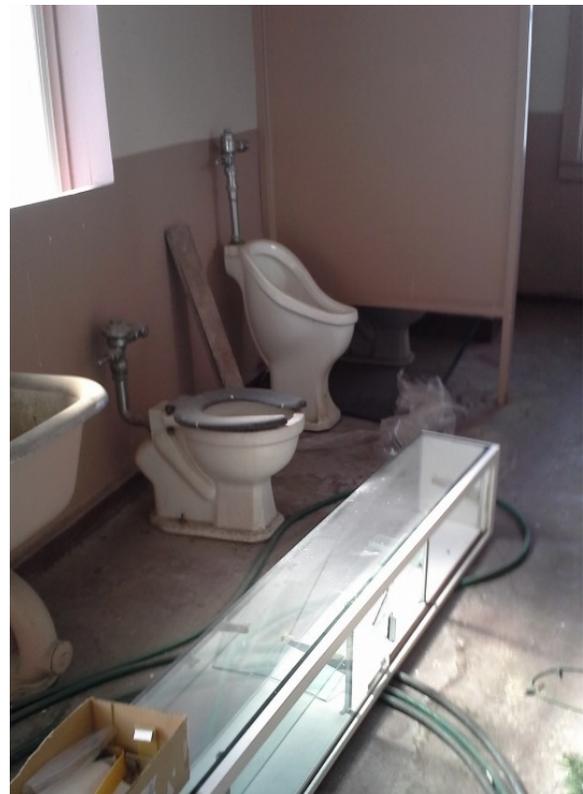
Plumbing fixtures have been abandoned and should be capped.

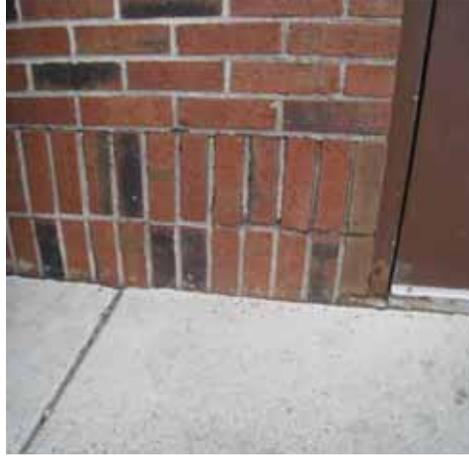
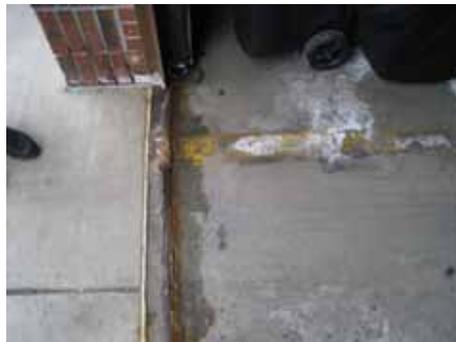
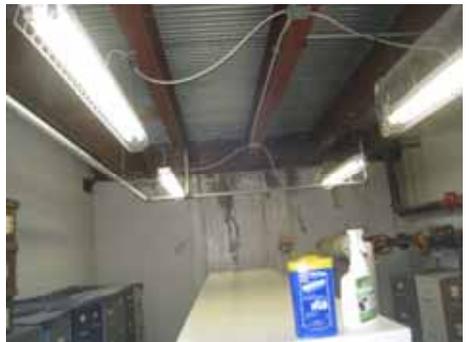
- Roof: Signs of leaking at transitions
- Foundation: Water entering basement at small garage and electrical conduit.
- Brick: Some salt damage of mortar
- Windows: Original, some air and water infiltration, due for repair
- Doors: Fair condition, with some salt damage

- Insufficient drainage away from building

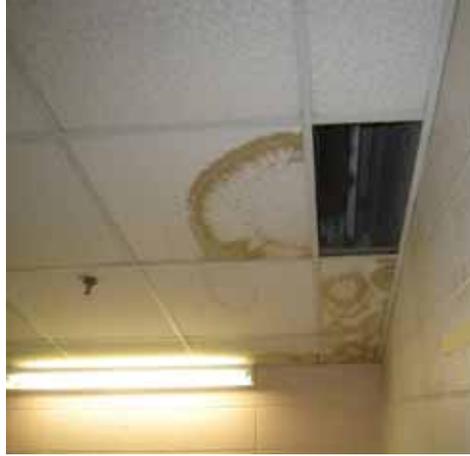
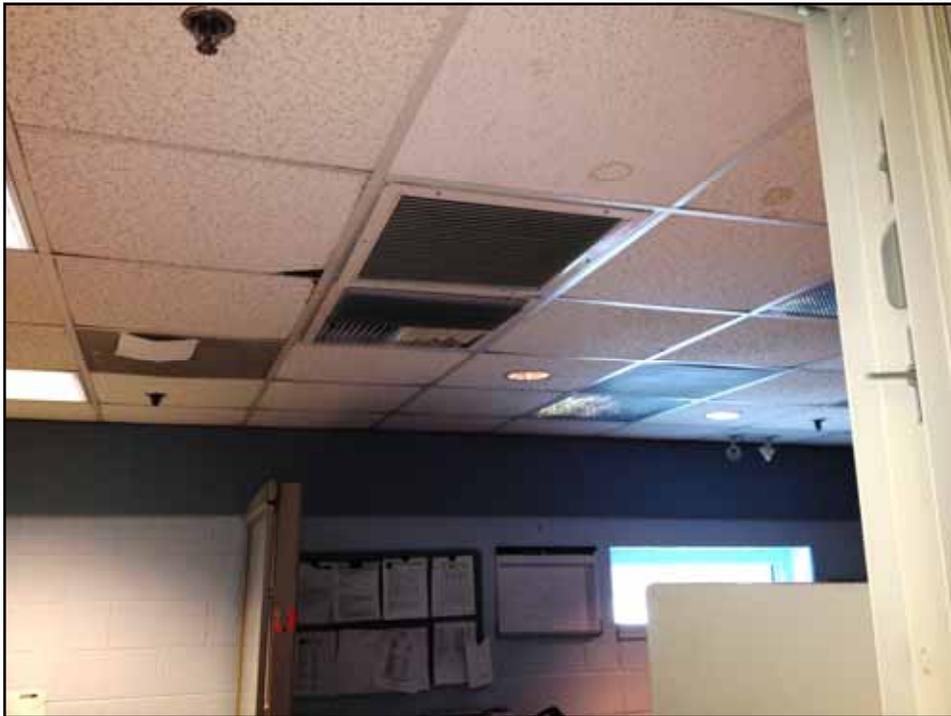
- Ceiling: Signs of water damage, panels damaged in dispatch area.
- Walls: Fair condition
- Floors: Carpet and VCT worn throughout building
- Doors: Good condition

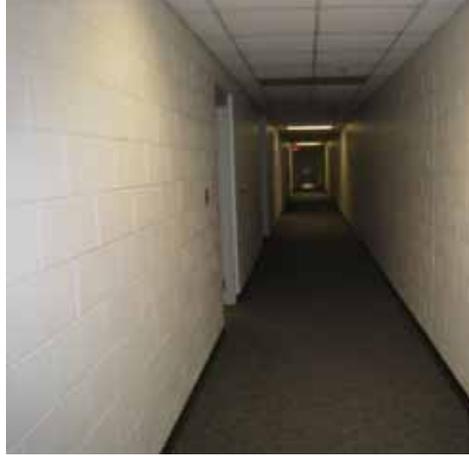
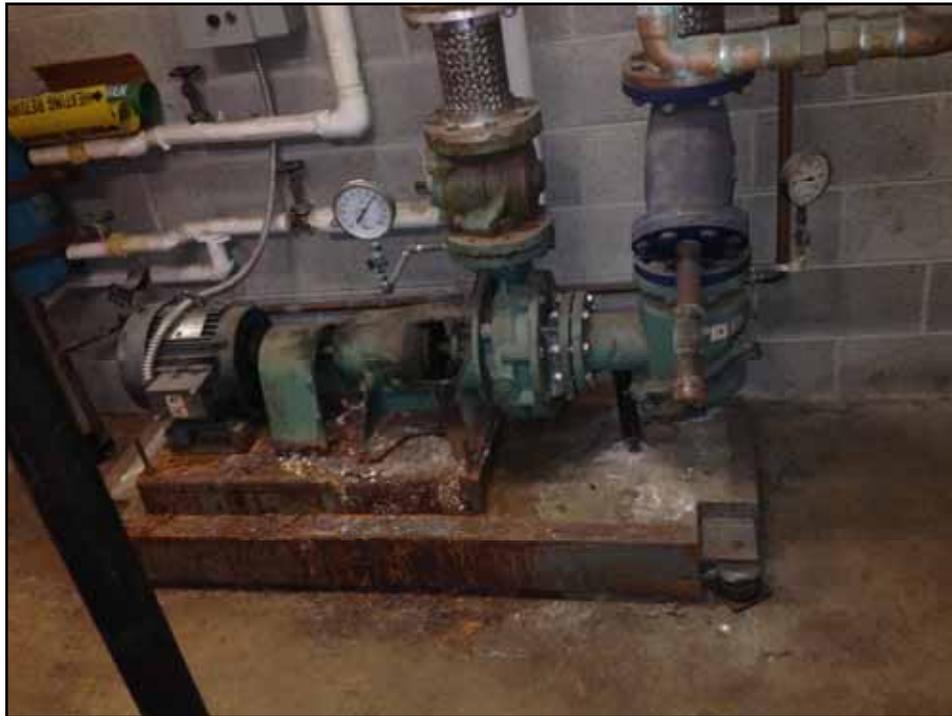
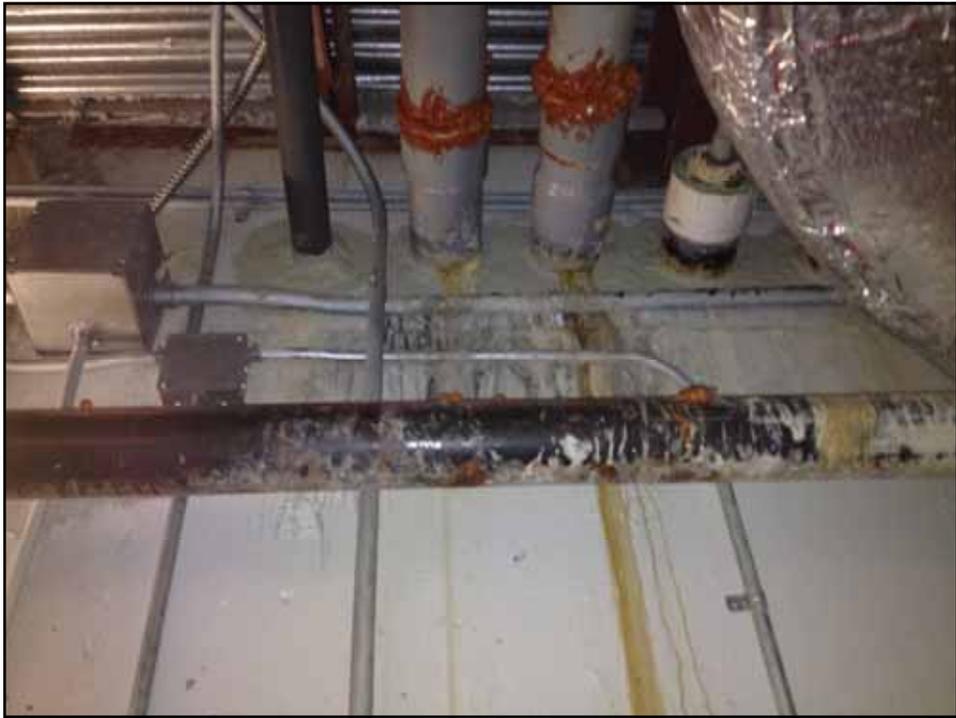
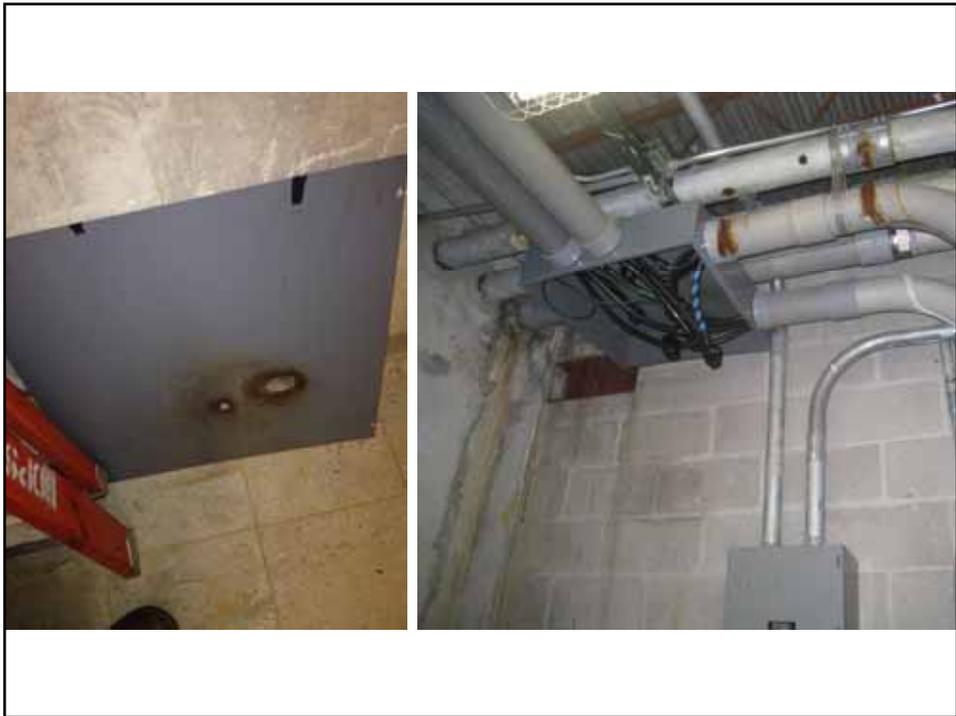
- HVAC: Original, at end of life. Controls malfunctioning, system in dispatch minimally functional and noisy. Shooting range exhaust insufficient. No vehicle exhaust system.
- Electrical and Lighting: Water in main electrical conduits. Corridor light levels are low.
- Plumbing: Original, hardware is worn.

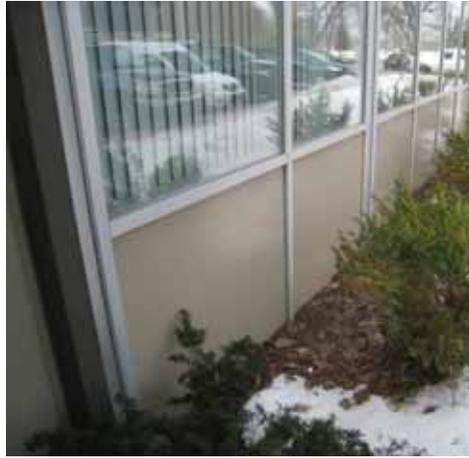
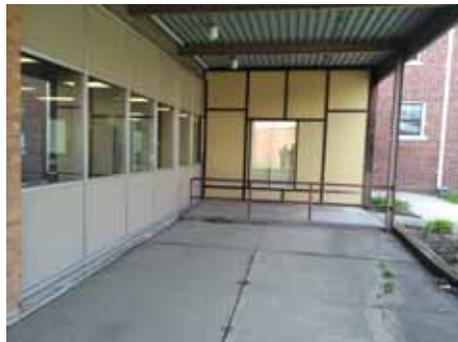
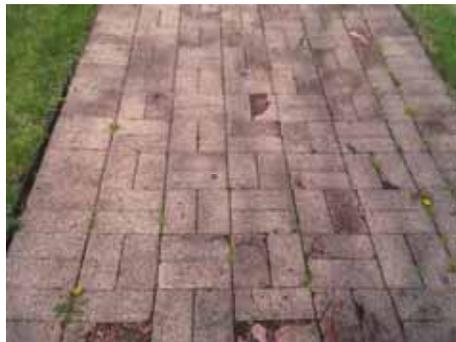
- Roof: Newer, some minor leaks
- Cladding: In good condition, except deteriorating wood clad west entry
- Windows: Newer units, in good condition
- Doors: Older aluminum doors, fair condition, hardware at end of life.

- Insufficient drainage away from building, water enters during heavy rains. Brick pavers deteriorating from water.

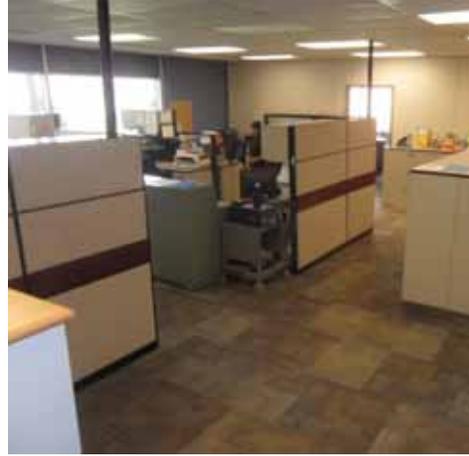
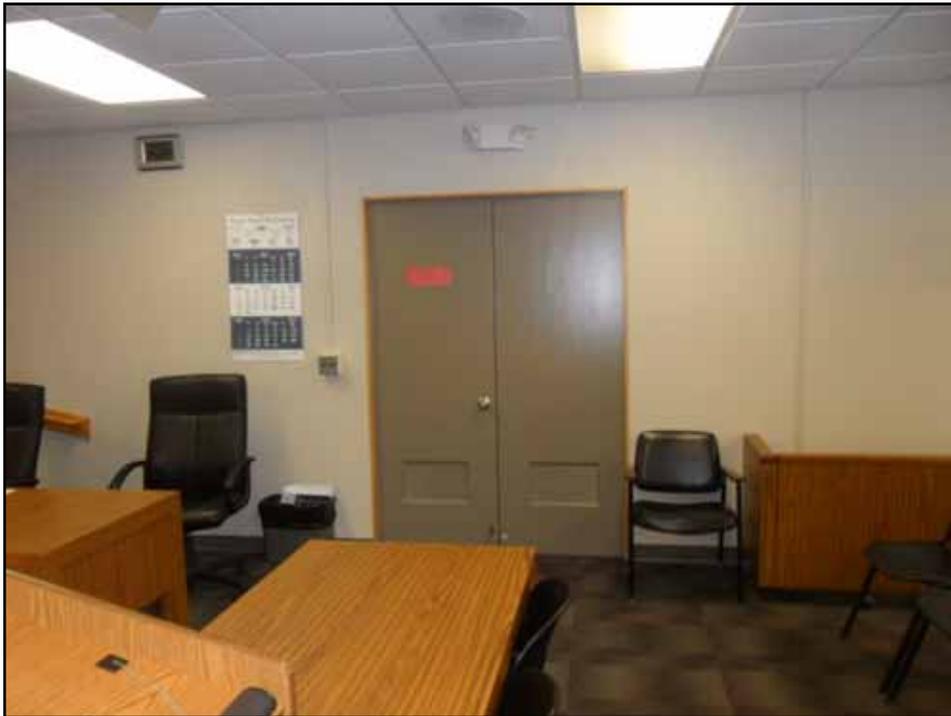
- Ceiling: Good condition
- Walls: Mix of types, good condition
- Floors: Mix of types, good condition
- Doors: Some hardware near end of life. Doors in council chamber undersized for egress.

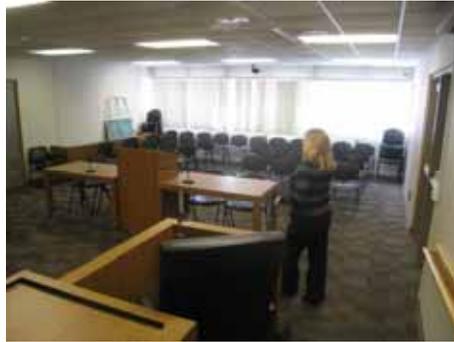
- HVAC: System functional, but outdated and inefficient, poorly controlled.
- Electrical and Lighting: Electrical system in good condition. Lighting inefficient, but in good condition.
- Plumbing: Fixtures in good condition. No fire protection.

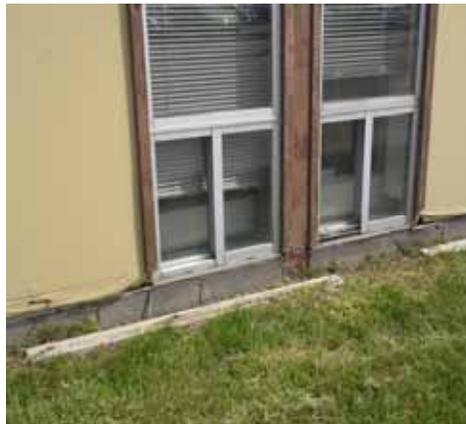
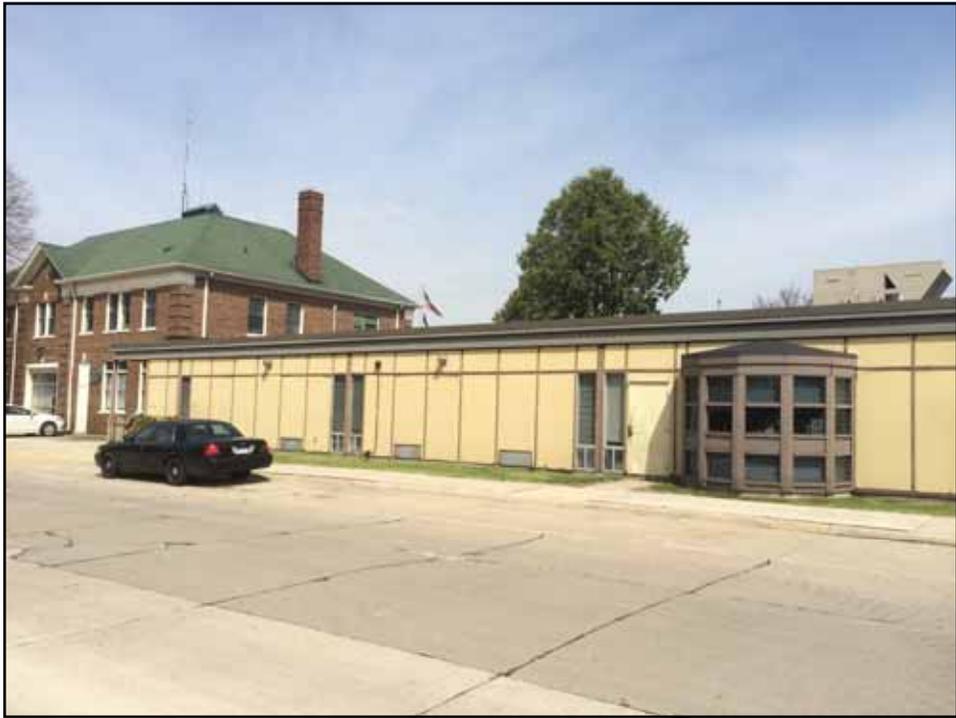
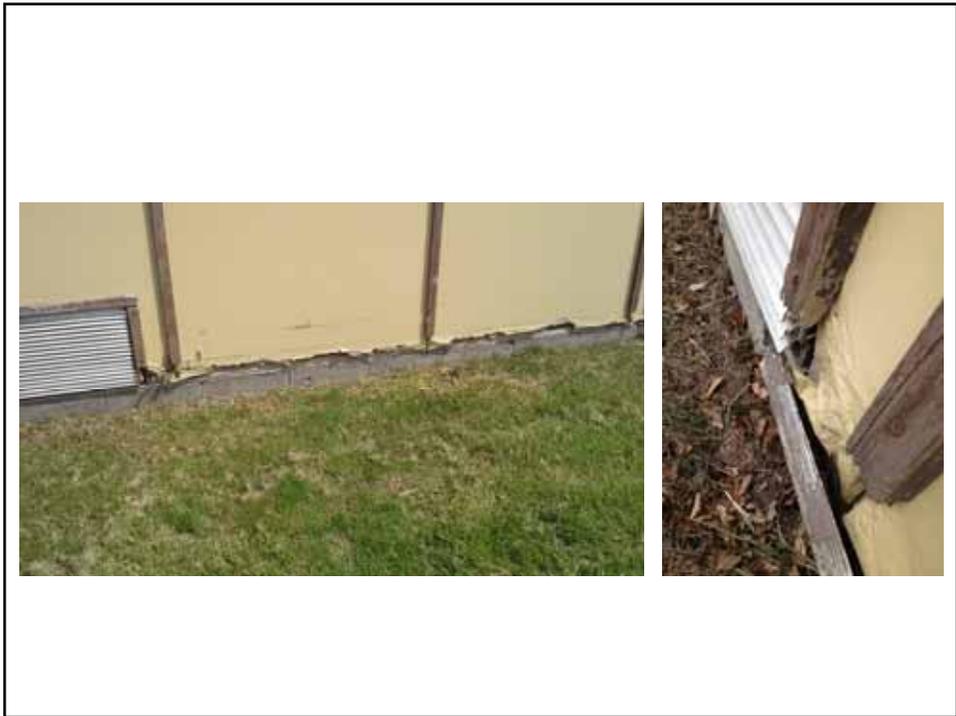
- Roof: no reported problems
- Cladding: Plywood skin and trim failed, building not water-tight.
- Windows: Poor condition, past end of life.
- Doors: Fair condition, at end of life.

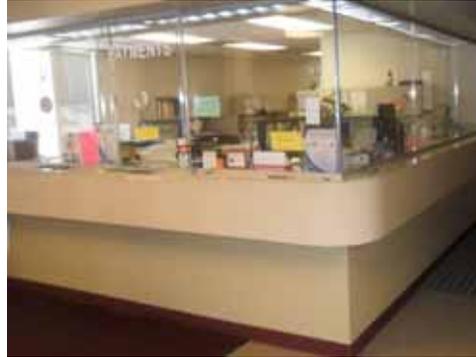
- Ceiling: Good condition
- Walls: Fair to good condition.
- Floors: Fair to good condition.
- Doors: Typically good condition.
- Casework: Countertops at end of life.

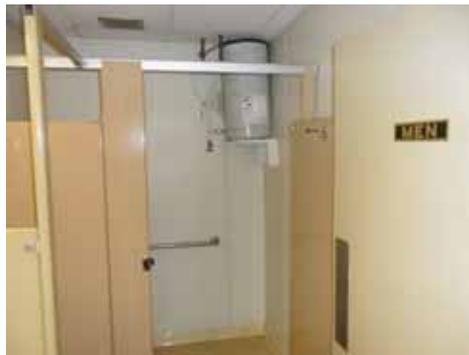
- Many spaces have accessibility issues  
Toilet rooms not updatable.

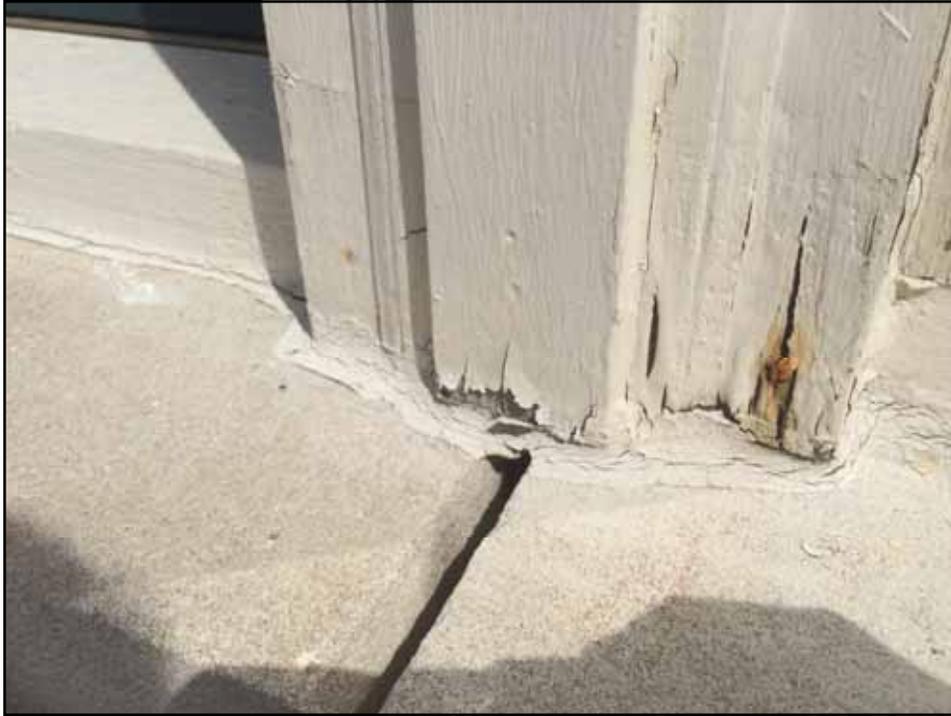
- Roof: Asphalt shingles, near end of life.
- Brick: Good condition, some stone work needed.
- Wood trim: Due for repair/repaint.
- Windows: Replacement units, fair condition.
- Doors: Newer, in fair condition.

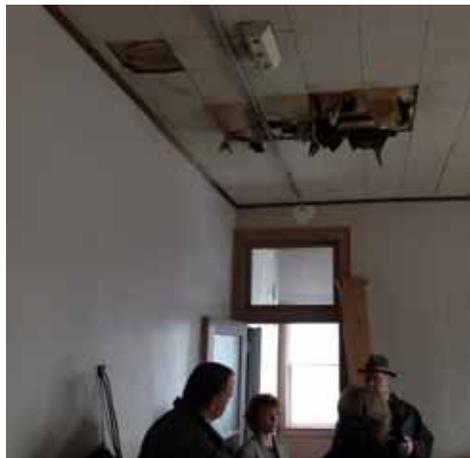
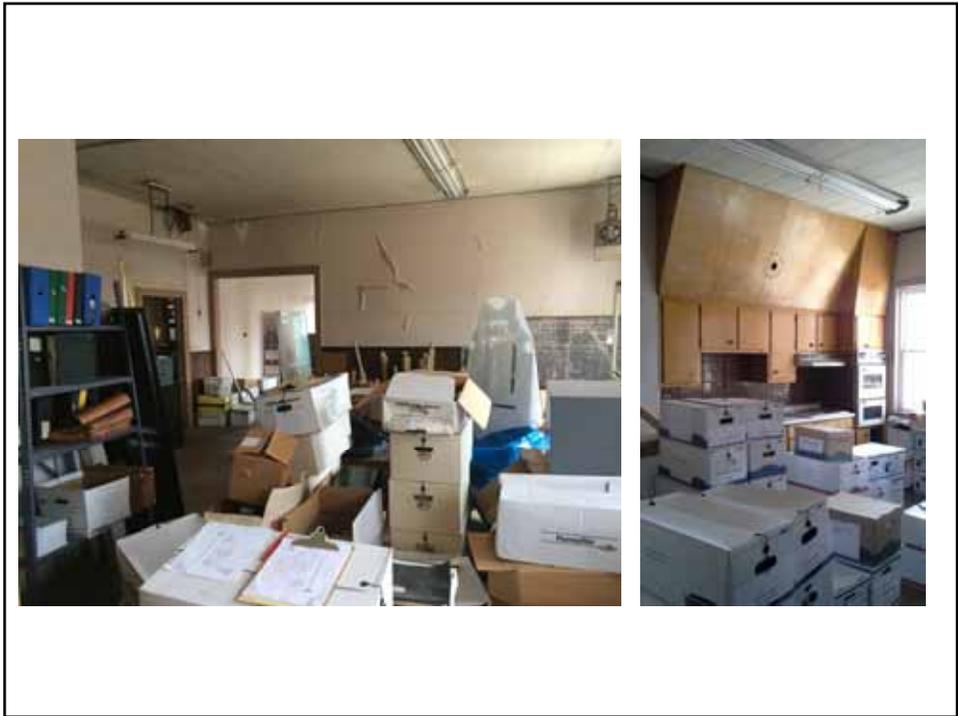
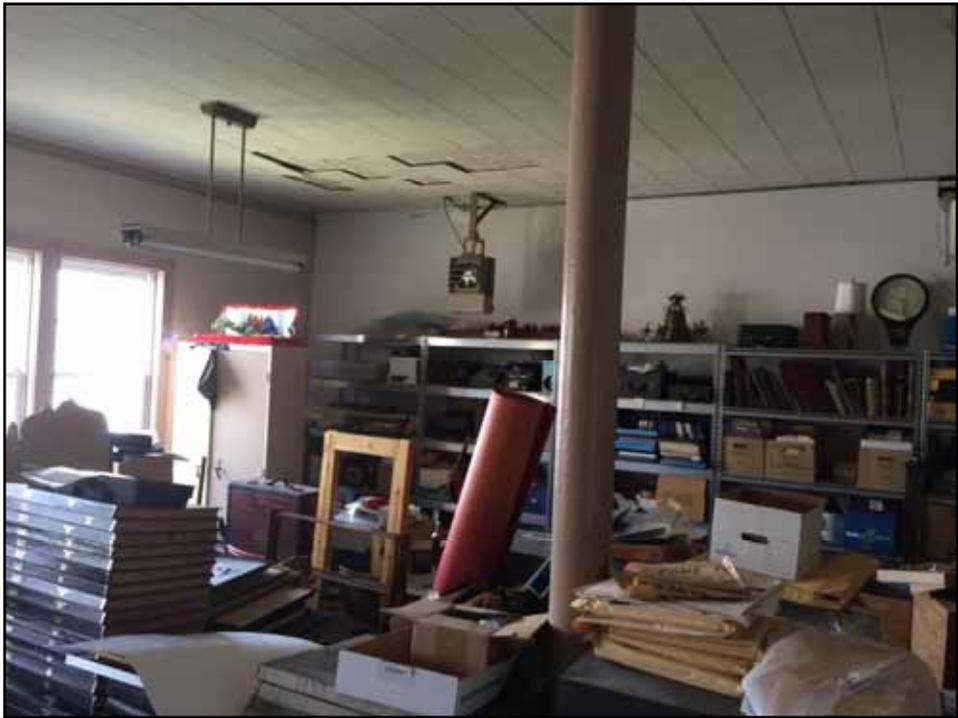
- Museum recently renovated.
- Ceiling: Level 1 - new lay-in ceiling. Level 2 - ceiling failed.
- Walls: Drywall, and plaster on studs and clay units. Level 1 in good condition, level 2 damaged.
- Floors: Level 1 - carpet, good condition. Level 2 - wood floor, worn, areas damaged.
- Doors: Level 1 - wood doors, good condition. Level 2 - doors past end of life.

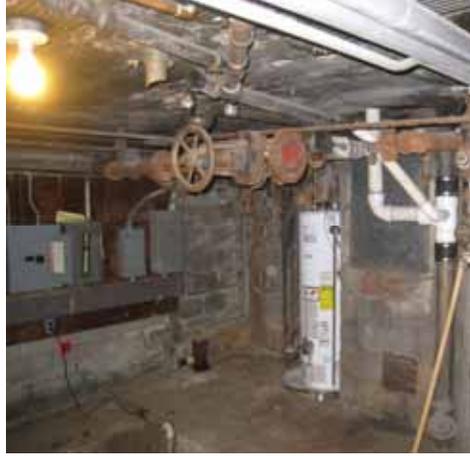
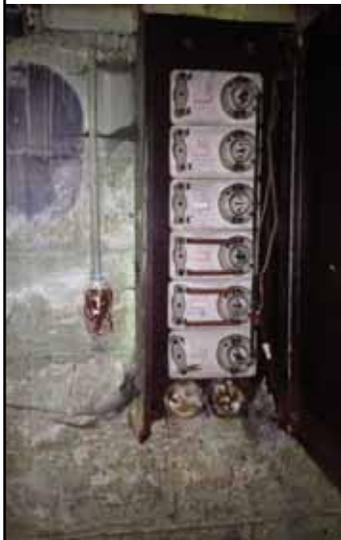
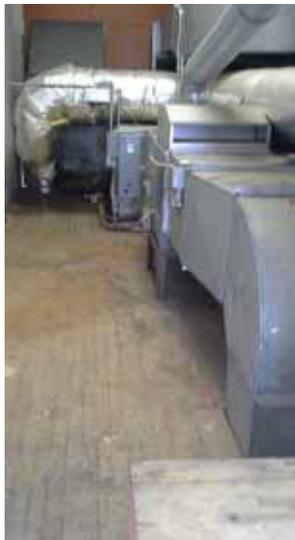
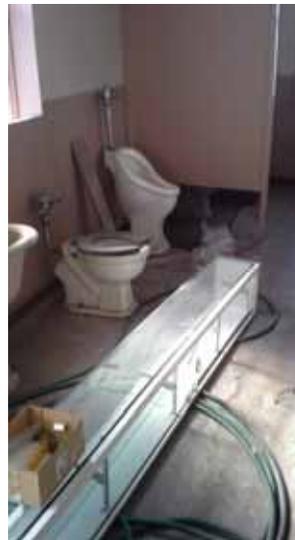
- HVAC: Level 1 system 25+ years old, fair condition. Level 2 has no HVAC system.
- Electrical: Power fed from City Hall, distribution in fair-poor condition. Live and abandoned system in basement. Insufficient clearance on active electrical panels.
- Lighting: Level 2 lighting past end of life.

- Building is not accessible, corridors narrow, no elevator.
- No fire protection system.

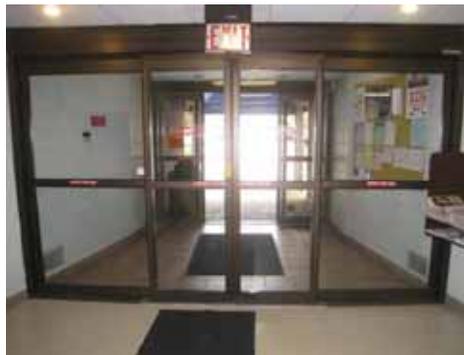
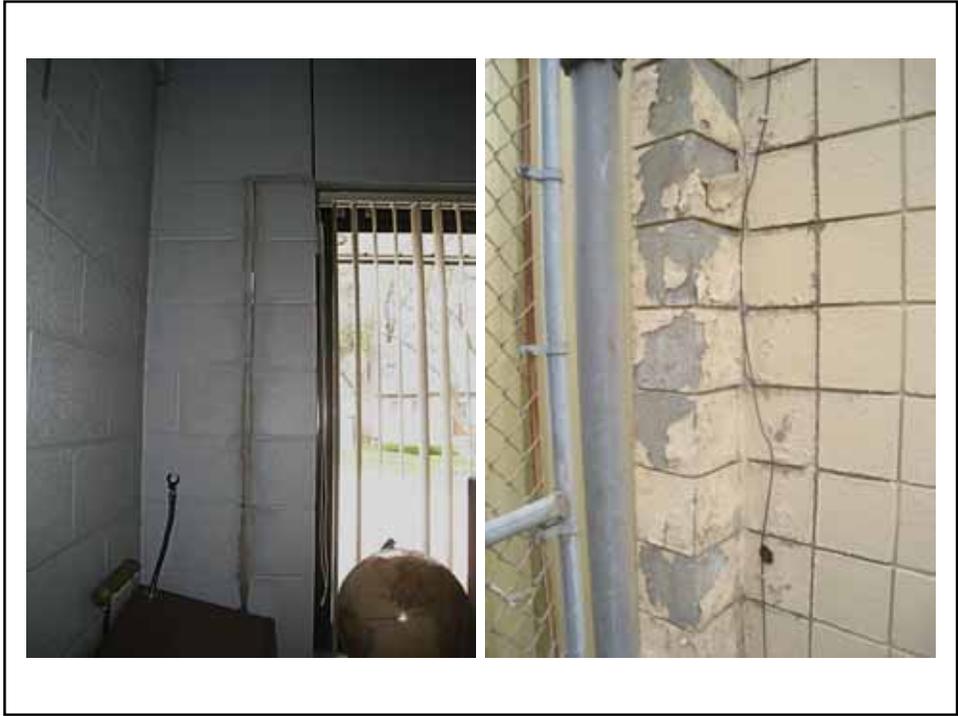
- Wall movement and cracking at northeast corner.

- Roof: Signs of leaks at wall transitions.
- Painted Block: Paint failed from roof drainage, block joints showing signs of freeze damage.

- Settlement and wall movement at northeast corner of building. Issues should be investigated and repaired.
- Roof drainage should be addressed to eliminate water and ice damage on wall.

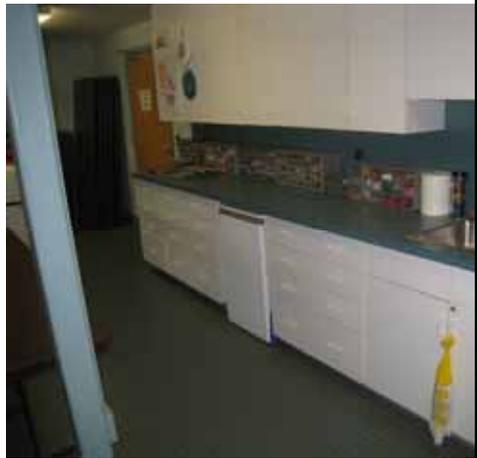
- Finishes are generally in fair to good condition for their age, but nearing expected end of life.

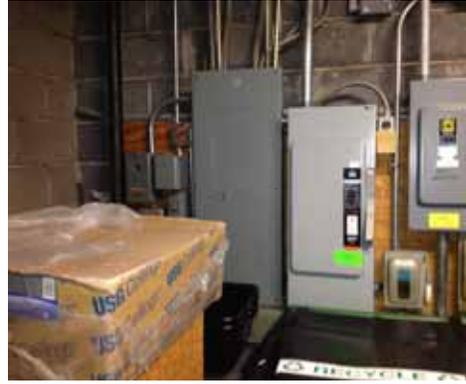
- HVAC: System not providing occupant comfort, residential units likely undersized. Inadequate ventilation to remove odors.
- Electrical: System at capacity – 6 switch limit.
- Lighting: Mix of types. Inefficient, but no reported problems.
- Plumbing: Most fixtures original, near end of life.

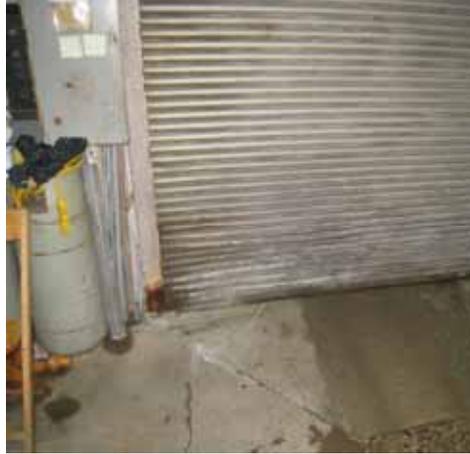
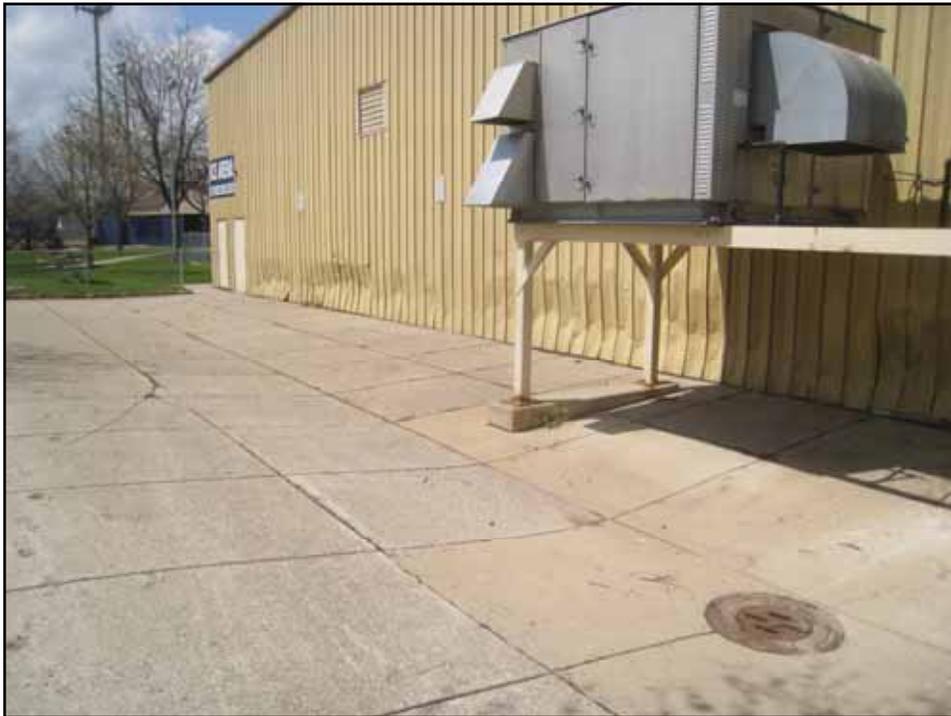
- Roof: Membrane on metal roof. Multiple leaks reported.
- Cladding: Painted block and painted metal panels. Metal panels are dented and due for repaint, especially at south end.
- Doors: Steel doors damaged, rusting. Overhead door damaged.

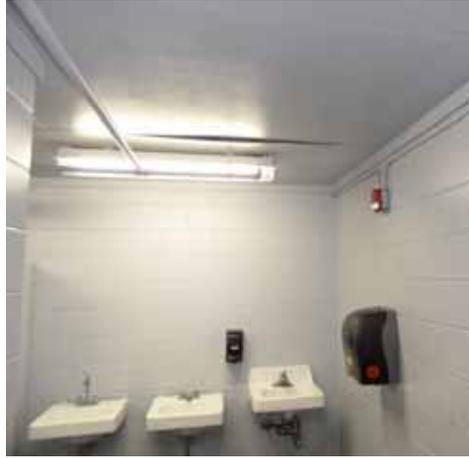
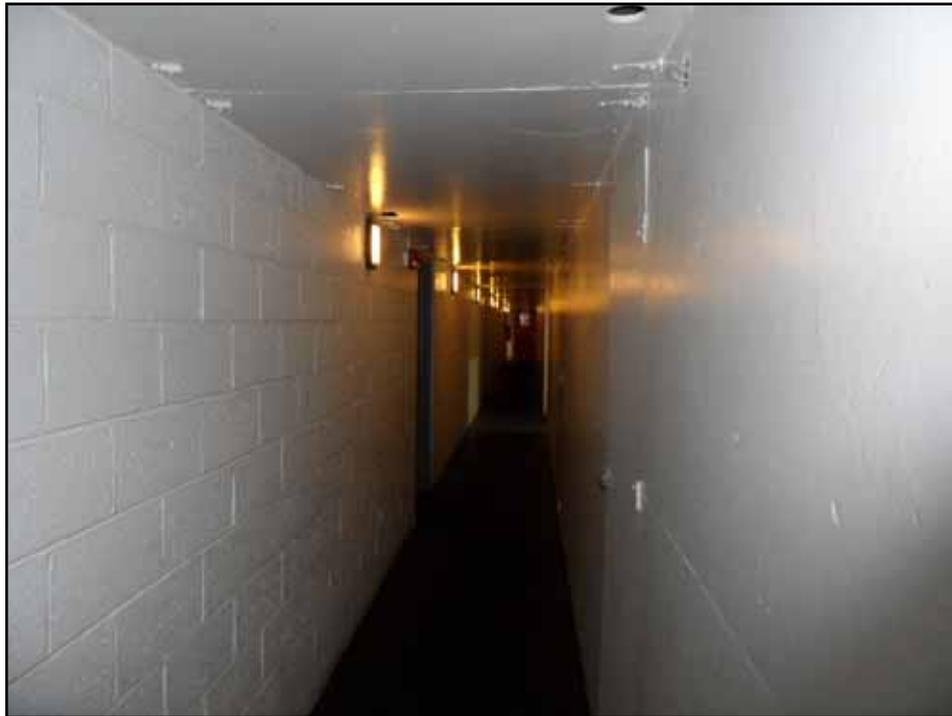
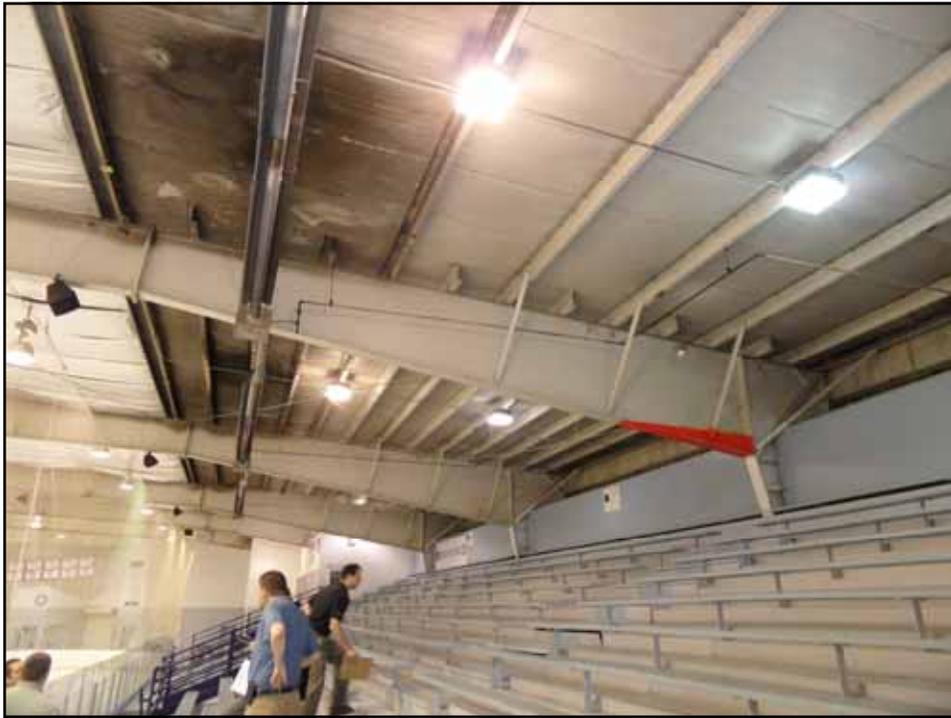
- Ceiling: mix of types, insulation in rink dirty, sagging and torn. Painted plywood ceilings in locker area and under bleachers.
- Walls: Painted plywood and painted block, typical damage for ice arena.
- Floors: No reported problems.
- Doors: Typical damage for ice arena.

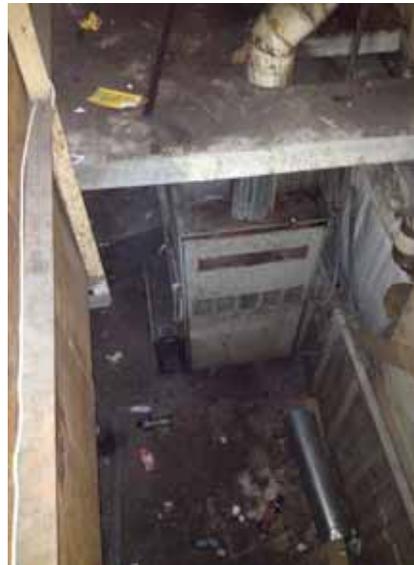
- Locker room furnace very old, has poor access, exposed to debris from spectators and too close to wood surround.
- Inadequate ventilation throughout.
- Sidewall louvers do not close fully.
- Gas heaters old, soot damaging roof insulation.
- Dehumidification system failing.
- Studio ice area has no HVAC system.

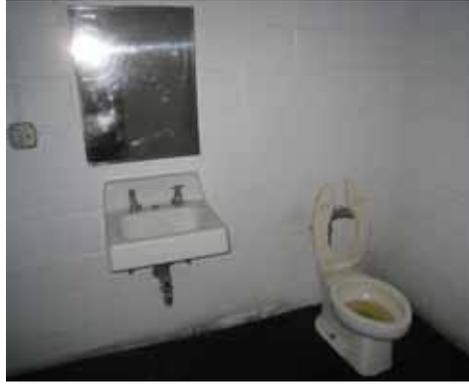
- Electrical: Main switchgear and panels are near end of life and due for replacement.
- Lighting: Mix of fluorescent and metal halide. Inefficient, but no reported problems. Egress corridor lighting levels low.
- Plumbing: Majority of fixtures original, damaged, near end of life.

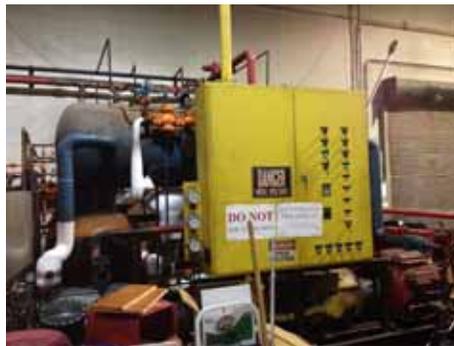
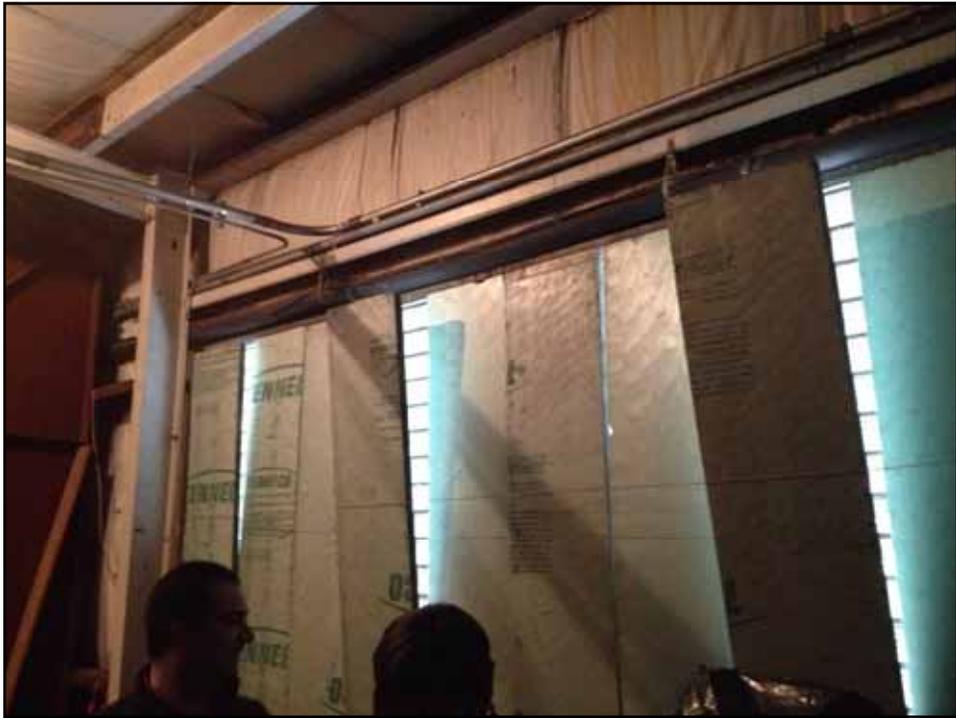
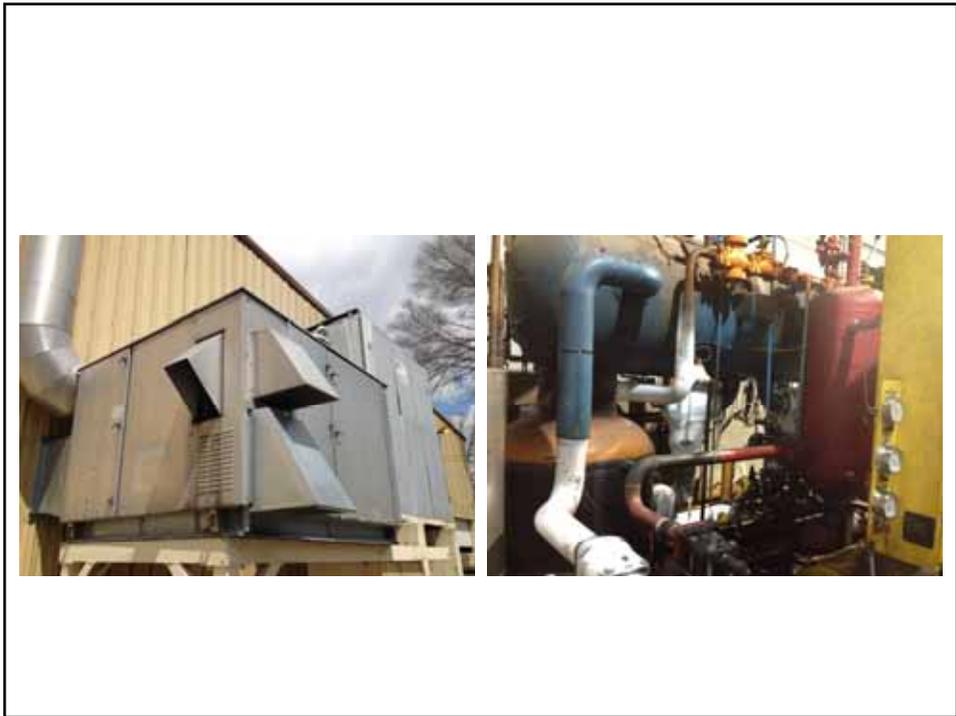
- Main Ice Plant: Entire system original, inefficient, past end of life.
- R22 refrigerant being phased out.
- One compressor failed, parts difficult to obtain.
- System difficult to restart.
- Cooling tower past end of expected life.

- Decommissioned.
- Intake louvers closed with insulation, but air still enters.
