**MUNICIPAL BUILDINGS FACILITY CONDITION ASSESSMENT  
CITY OF BERKLEY, MICHIGAN**

**AUGUST 2014**

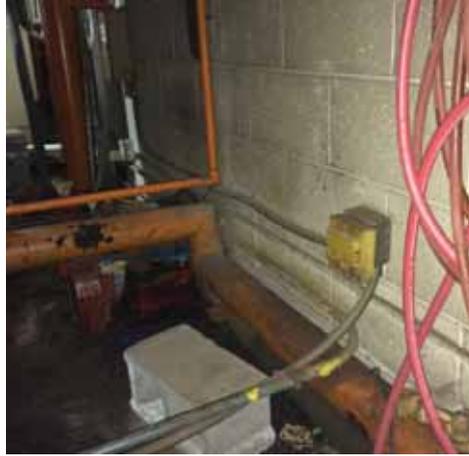
- Fire department connection poorly marked.
- HVAC unit under bleachers should be removed and relocated.
- Under-bleacher walls and ceilings are painted plywood.
- The ice plant systems are past useful life.
- R-22 leak alarm is audio only. No external visual alarm or exhaust system.

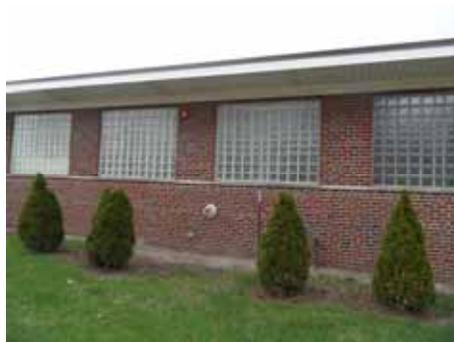
- Roof: Good condition
- Brick in good condition for age  
 Block due for repaint
- Windows: Glass block in good condition.  
 Metal frame units due for replacement.
- Doors: Metal doors and overhead doors in fair condition.

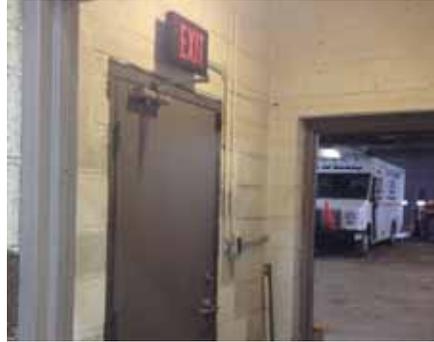
- Ceiling: Mostly open to deck. Ceiling in staff area in poor condition
- Walls: Good condition
- Floors: Worn VCT, fair concrete.
- Doors: Good condition. Exit hardware and signage is incorrect and potentially confusing.

- Egress door issues should be corrected.
- Storage mezzanine railing very low and open.
- Fuel and chemical storage and containment should be corrected.
- Many building systems are past end of service life and due for replacement.

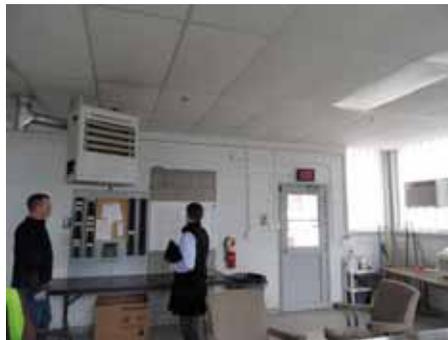
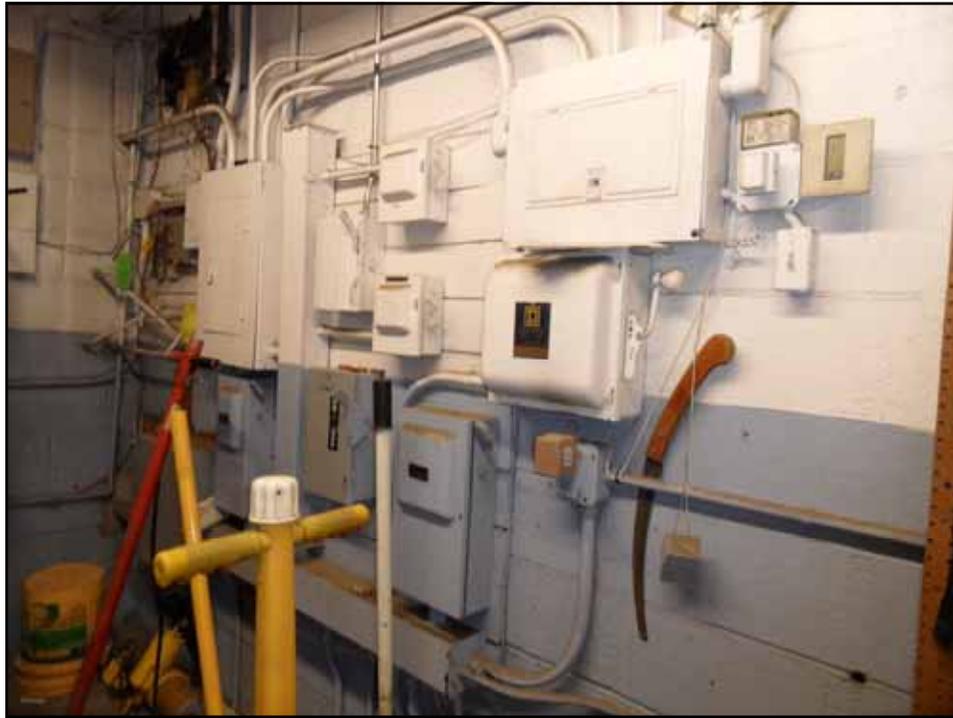
- HVAC: Low levels of ventilation provided in garage and staff space. Heating system poorly controlled, at end of expected life
- Electrical and Lighting: Electrical gear past end of life, complex and due for replacement. Lighting fair condition for use.
- Plumbing: Fixtures worn. No containment for oil or chemical spills. Fire protection in garage only.

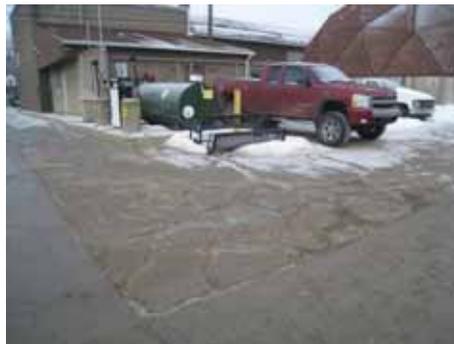
- Roof: Mix of types, fair condition
- Cladding: Brick in good condition, block patched and due for repaint
- Windows: Residential grade units and glass block - in fair condition, but inefficient
- Doors: Metal doors and overhead doors in fair condition

- Paving worn, site wall due for tuckpointing

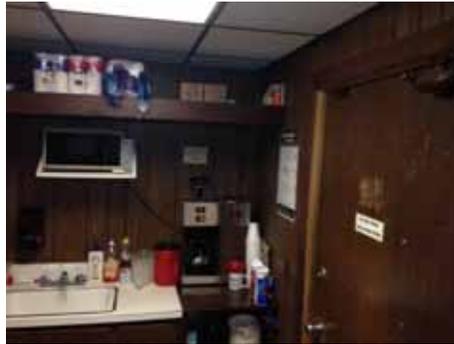
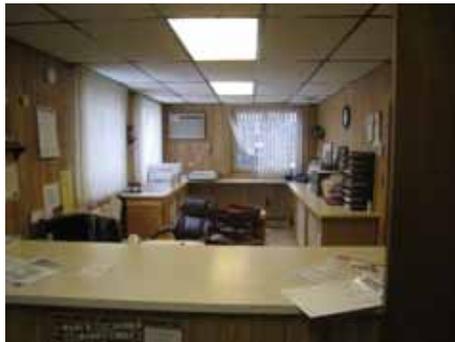
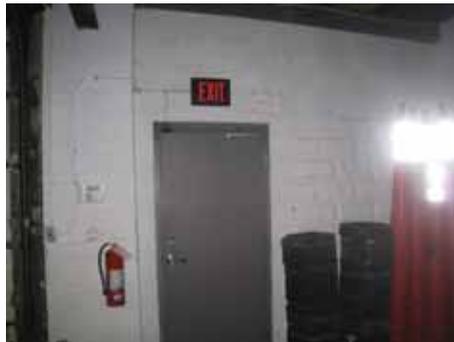
- Ceiling: Mostly open to deck. Much of deck is wood. Lay-in ceiling in staff area in fair condition
- Walls: Good condition. Fire separation between garage and office not continuous.
- Floors: Worn VCT, fair concrete in garage.
- Doors: Fair/poor condition. Exit hardware and signage is incorrect and potentially confusing.

- Signed egress door issues should be corrected.
- Interruptions in fire separation between spaces should be corrected.
- Deteriorated boiler flue should be repaired.

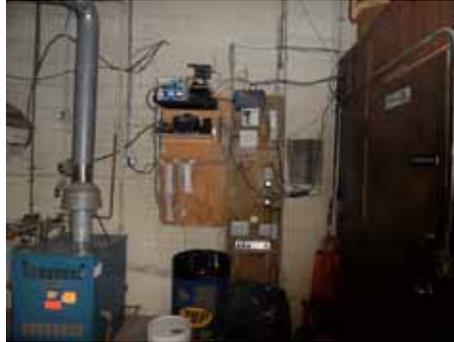
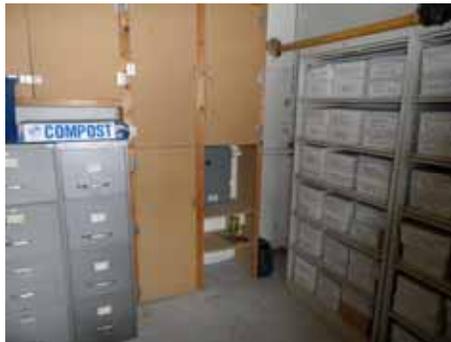
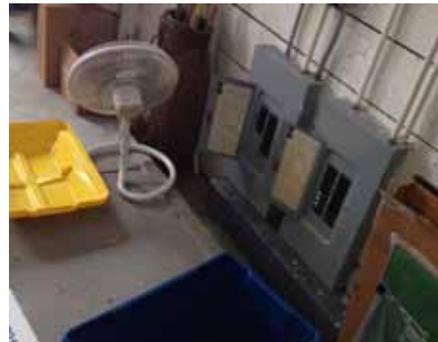
- HVAC: Low levels of ventilation provided in garage and staff space.  
Boiler poorly located, chimney leaking water.  
Gas-fired heaters at end of expected life
- Electrical and Lighting: Gear past end of life, insufficient clearance, due for replacement.  
Lighting in fair condition for use.
- Plumbing: Fixtures worn.  
No containment for oil or chemical spills. Fire protection in garage only.

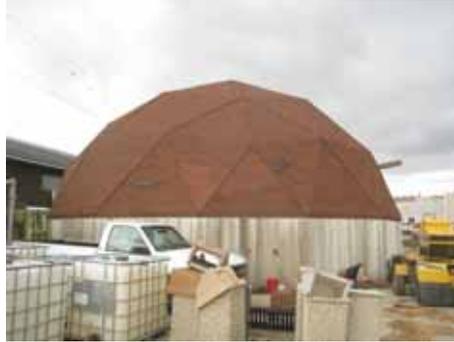
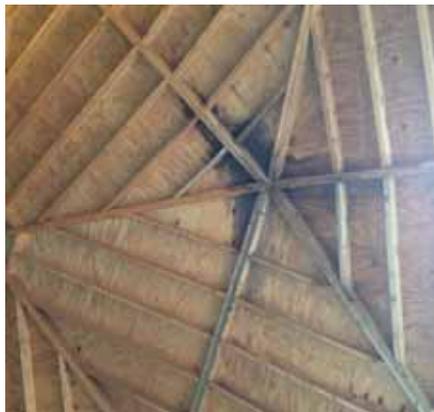
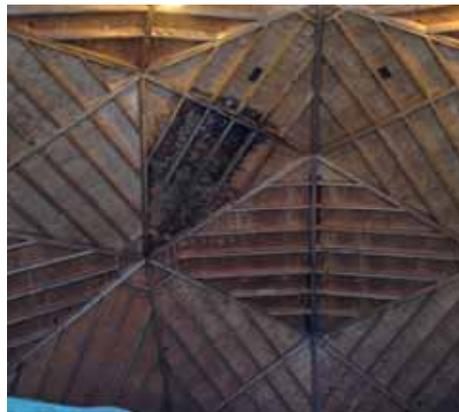
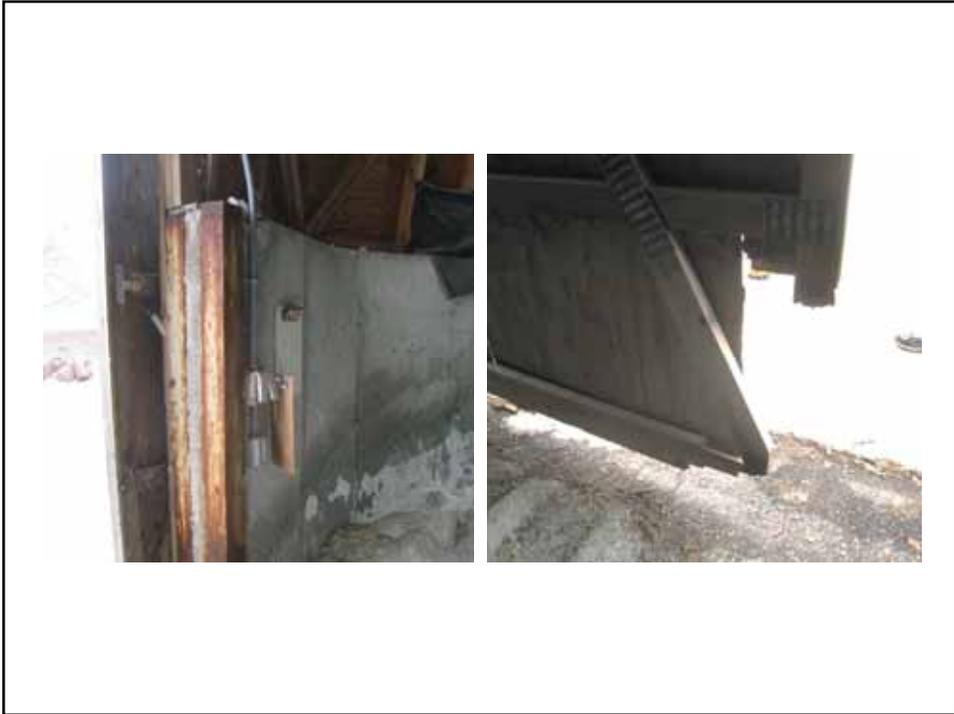
- Roof: Shingles past end of life and failing, wood deck water-damaged. Repair/replacement may be difficult.
- Concrete: Wall in good condition, steel frame rusted.
- Doors: Sliding wood doors damaged, failing.

- Surrounding paving deteriorated and due for replacement
